Intro

But today we will look on old unit, still wearing HP logo, manufactured somewhat in 1996. It was purchased as “parts, non-functional” piece for \$750 USD, which is below market price, even for broken meters. Perhaps you thinking “this guy is nuts, paying that money for 20 year old broken machine”. But think for a second, metrology-grade instrumentation market is very conservative. There are only 11 (eleven, that’s right) 8½-digit DMM models in the world, all vendors combined.

Let's see what we have to do to get unit back to operational state. My plan for this project is to perform full component level repair, and perform overall study of instrument's internal construction, as repair advances. This means we will not be doing expensive boards swap unless absolutely unavoidable.

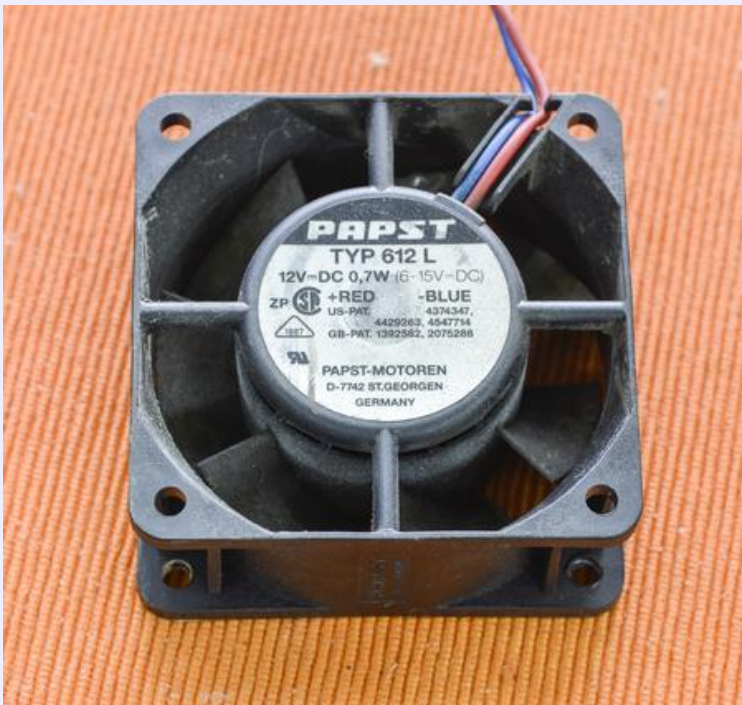
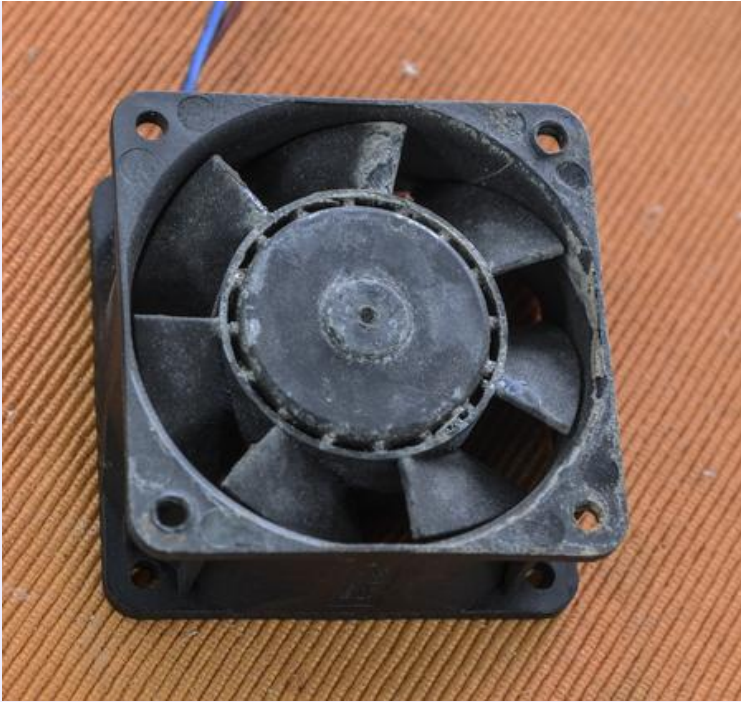
Black 2-pin connector at left of regulator is fan header. Fan in my unit is completely stuck and blocked by gunk, so instead of wasting time on fan cleaning, I'll just replace it with same spec'd new one from NMB.

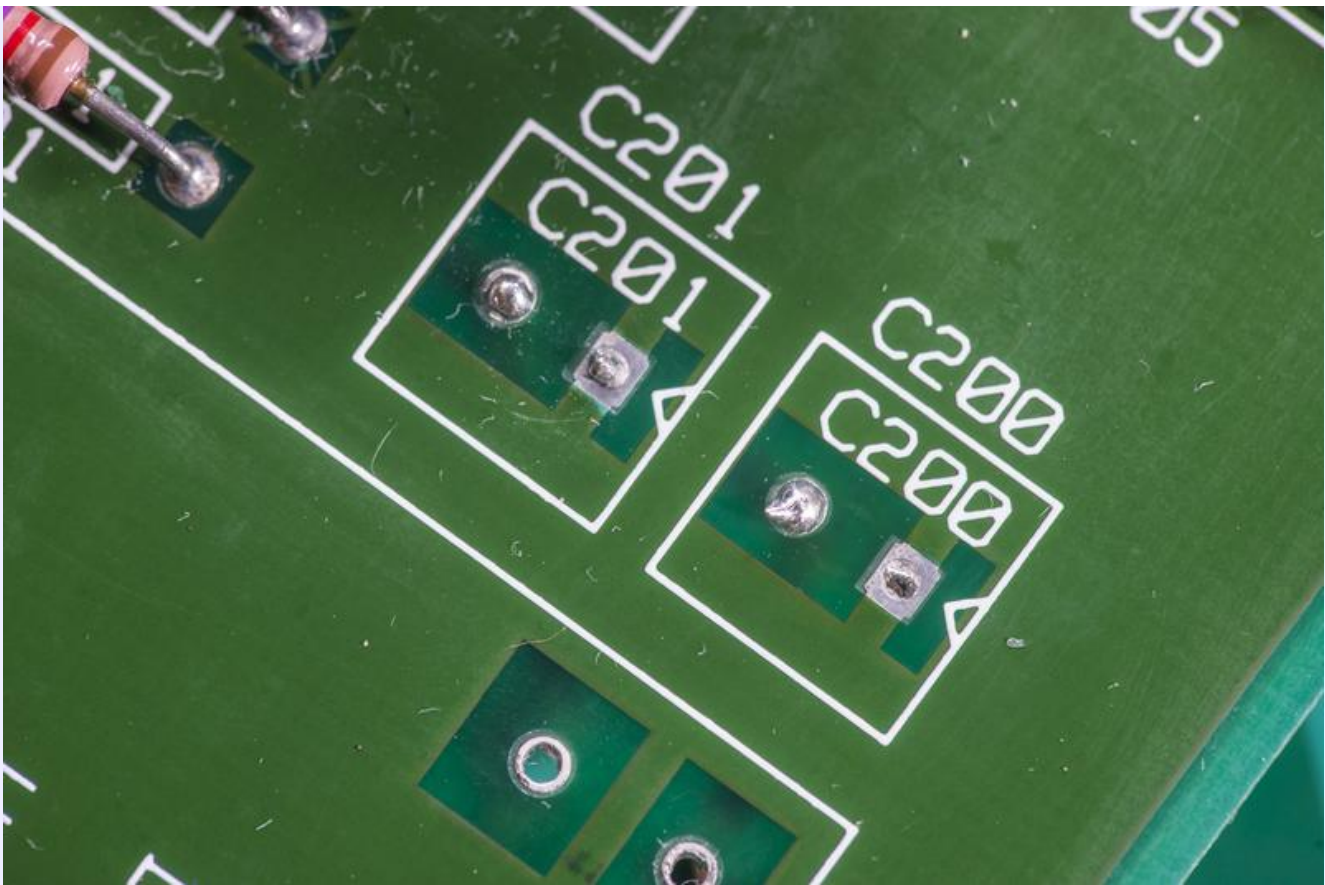
Now it's visible. Electrolyte got already out and started its destruction activities. Green pieces are actual PCB's solder mask.

Now I am really glad that we did not cut corners here, and removed them. And it's nice to have HP 3458A with only 2-layer PCBs, no risk of inner damages. I'll just clean it to shiny copper, add layer polyurethane enamel film around pins, just to be future-proof. Caps I bought from DigiKey are long-life, rated for +105°C, and so should work a treat for many years after replacement.

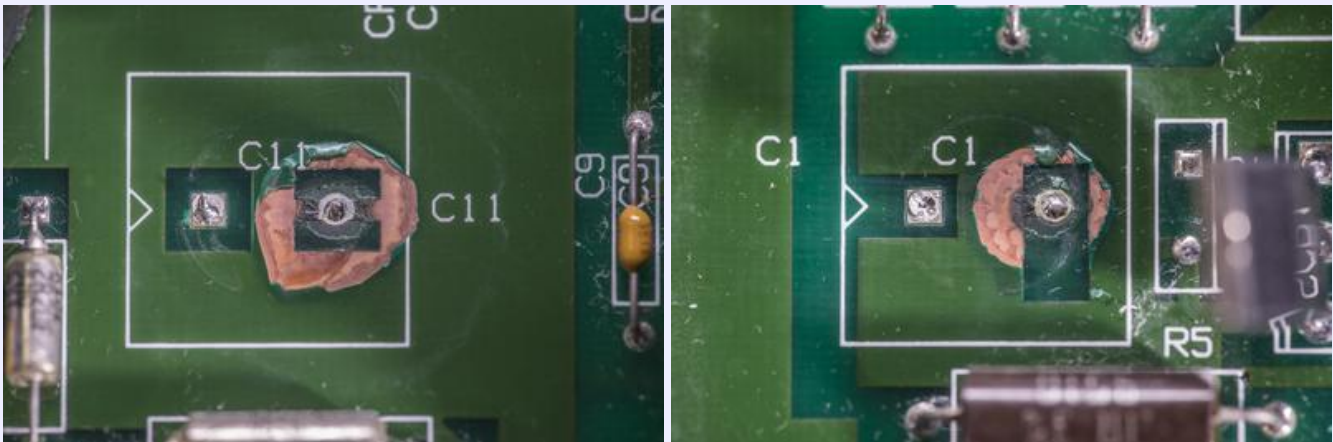
Small ones did not do any damage (yet), but bigger ones...

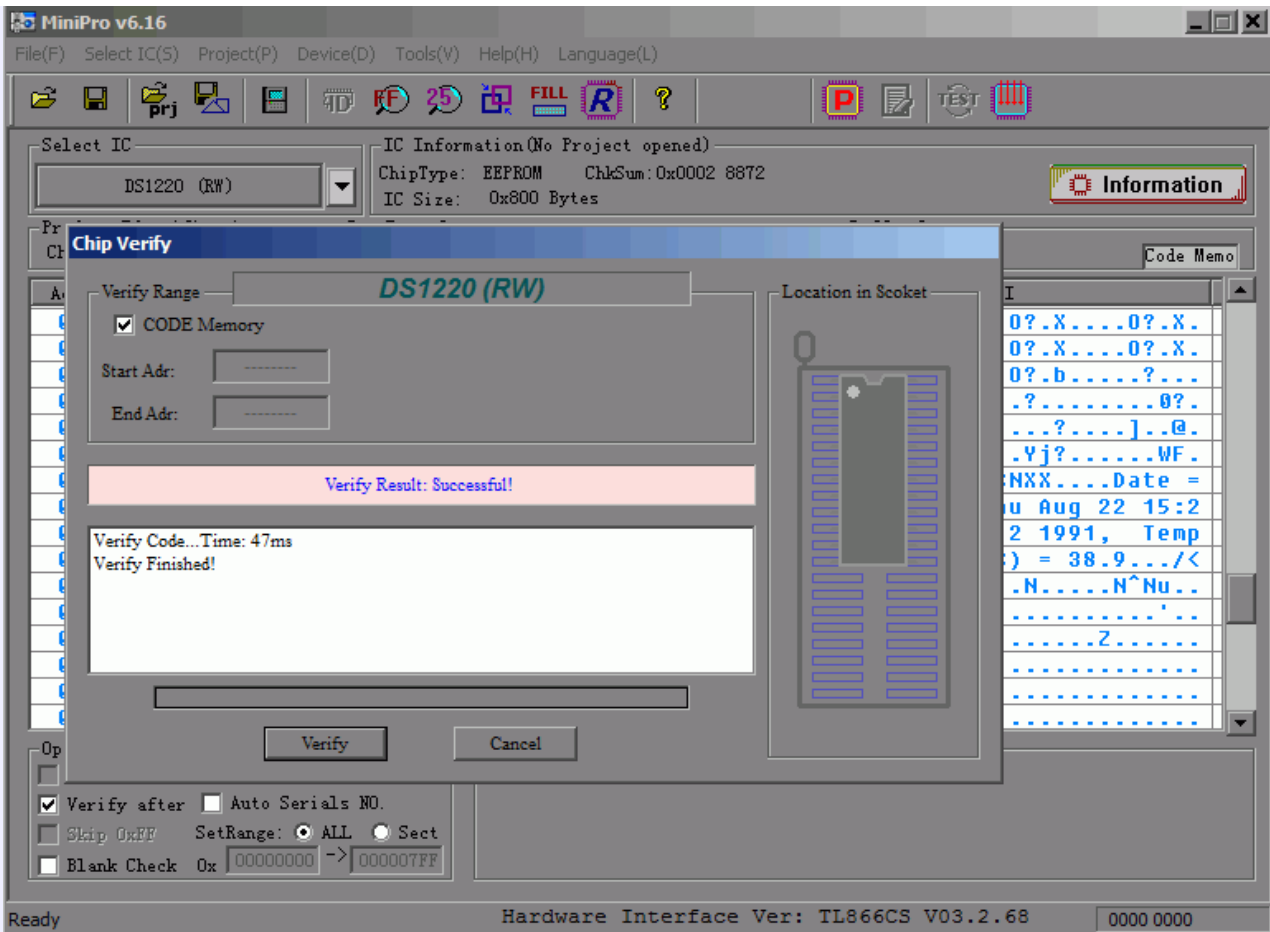
Date of calibration recorded in plain ASCII, saying 1991 year. This makes it rather useless, as in 24 years resistors and parts in meter drifted more than such old data could be used, as original DC reference board is missing. But since we have nothing better, I will copy this data into new Dallas DS1220 so we can use it as starting point.

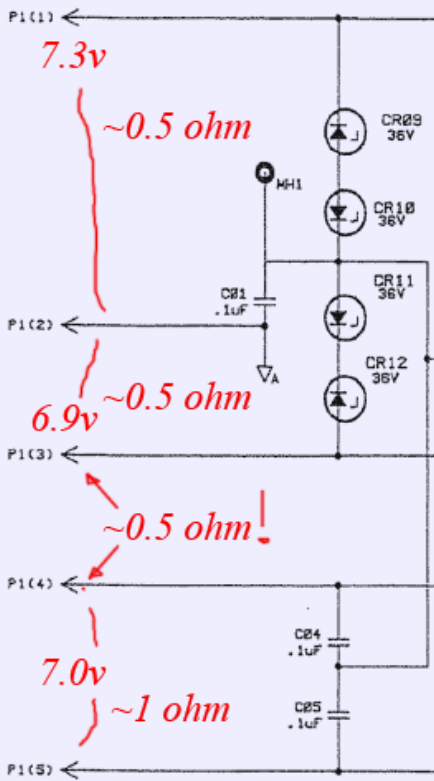
! This could be a result of 220 VAC is applied, while rear line voltage selection switches are set for 120 VAC.

I would not trust repaired/rewinded transformer in such an instrument anyway, so we going to make Keysight richer for \$337. That's new transformer cost.

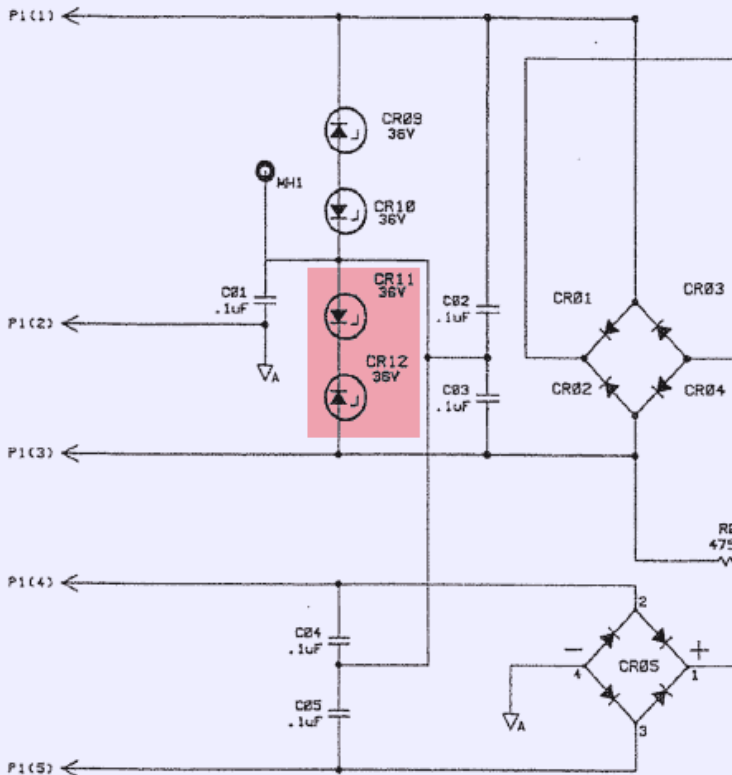
Now we can look on A4 PCBA, and quickly spot visible damage occurred on zener diode CR11. Quick measurement indicated that diode is dead shorted, as well as CR12. These **IN5365B 36V Zeners** rated for 0.4W power and function as overvoltage protection clamps before linear regulators.

In case of voltage presence over rated zener's 36V, diode will start conducting, directing current flow into ground, and limiting voltage on protected rail.

But first, replaced original CR11,CR12 with fresh zeners (got 50pcs from eBay, just few dollars with free shipping).

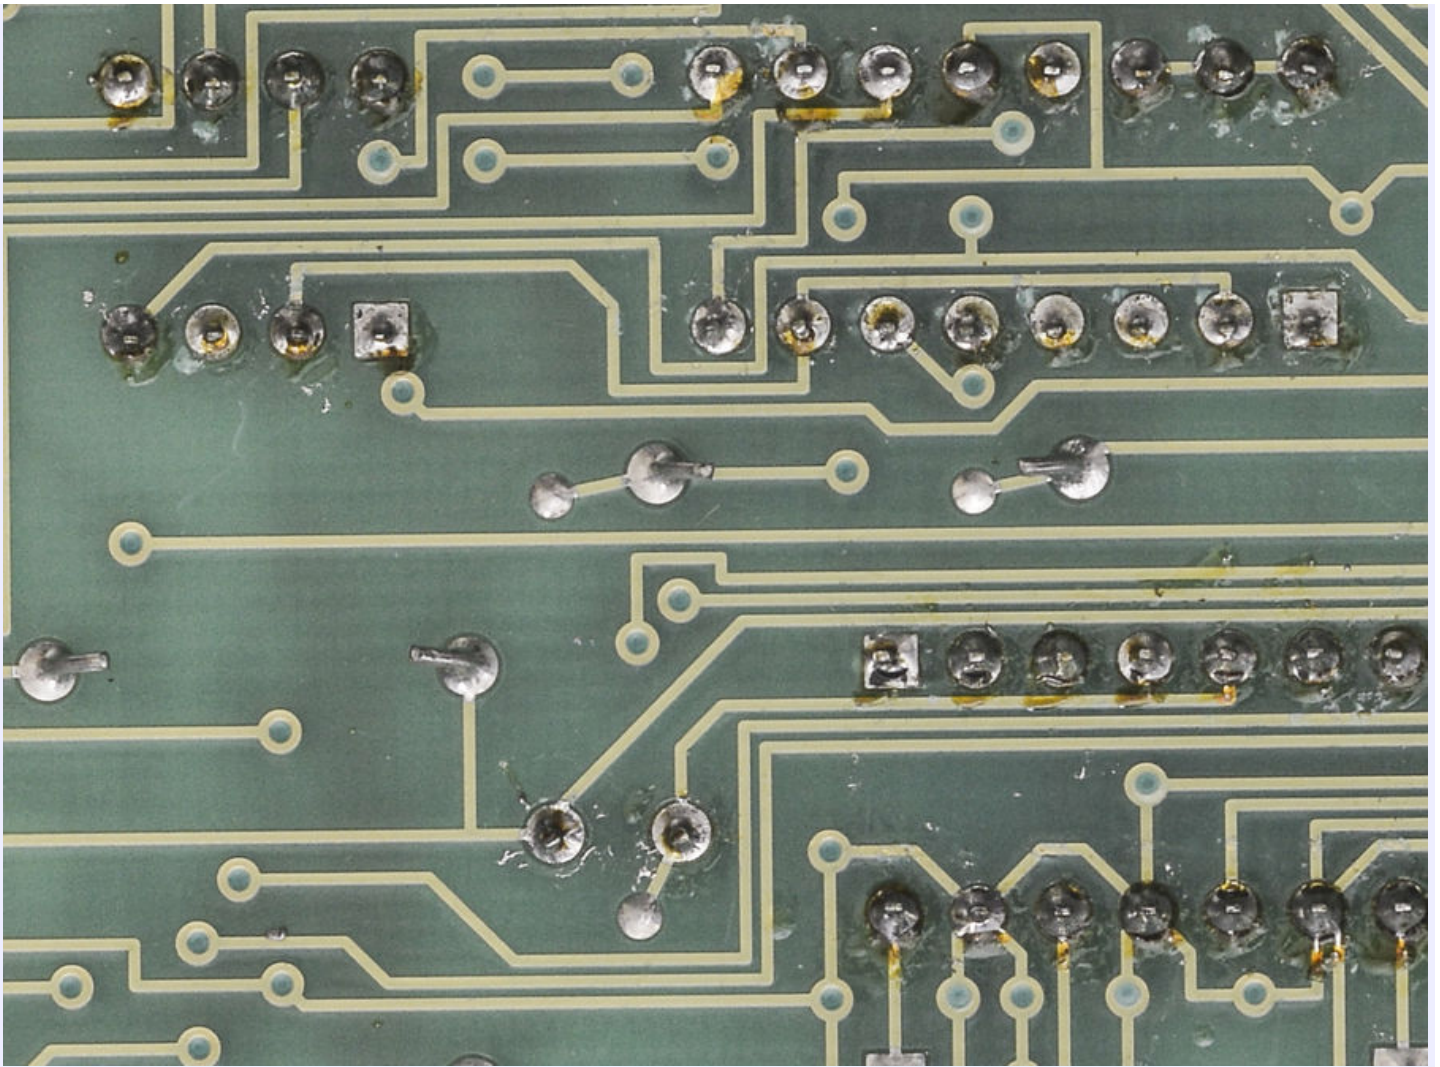
This board also have mark "X" around reference header, also paper tape sticker "X" in center of board near RP7 resistor network. Visual inspection shows ugly soldering and flux around parts U300, U305, U301, RP300, U304, U306, RP301, U303, RP302, RP303, R308, R307, R310, RP200 and around all relays (K1, K2, K3, K4, K5, K6, K7, K9, K200, K201, K202, K203, and K204). Relays have date codes from 1997, while rest of the board IC's dated 1995-1996. Previous owner tried to fix board by replacing relays?

Looking not good, if you ask me. That's why even broken gear sold by inexperienced owner, without attempts of non-qualified repair is easier to restore than hardware which looks mint externally, but have solder bodes and flux all over the field inside. Oh well, let's continue.

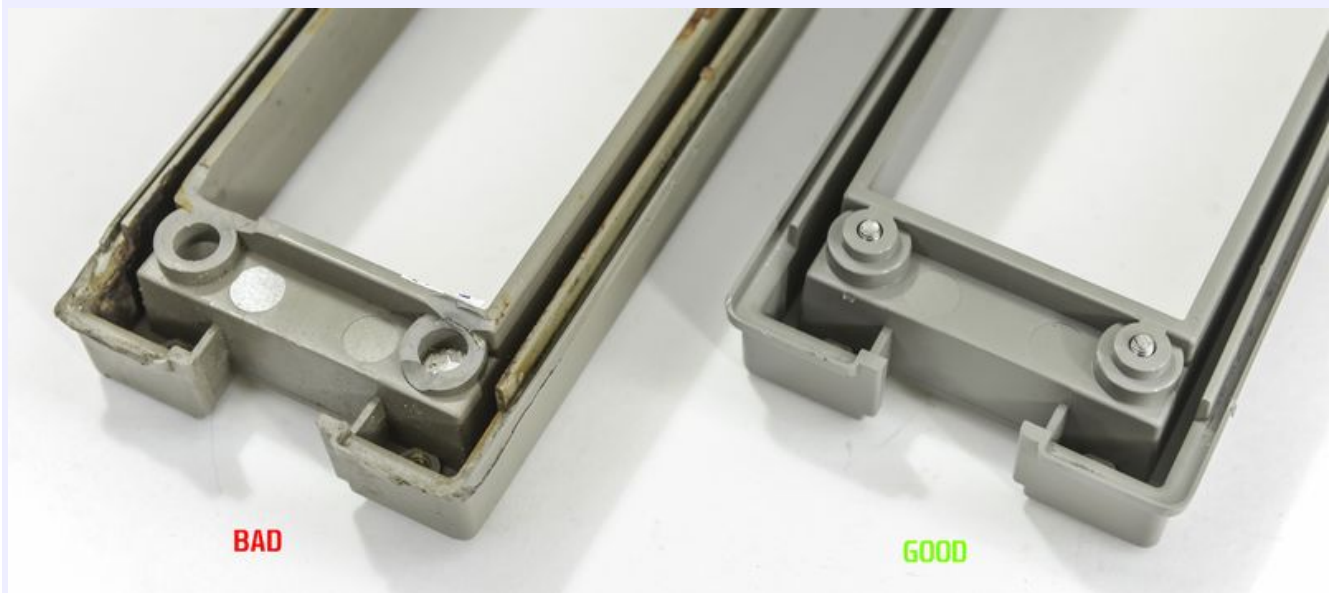
Original unit's bezel had three out of four screw mounts destroyed, so it was not holding well.

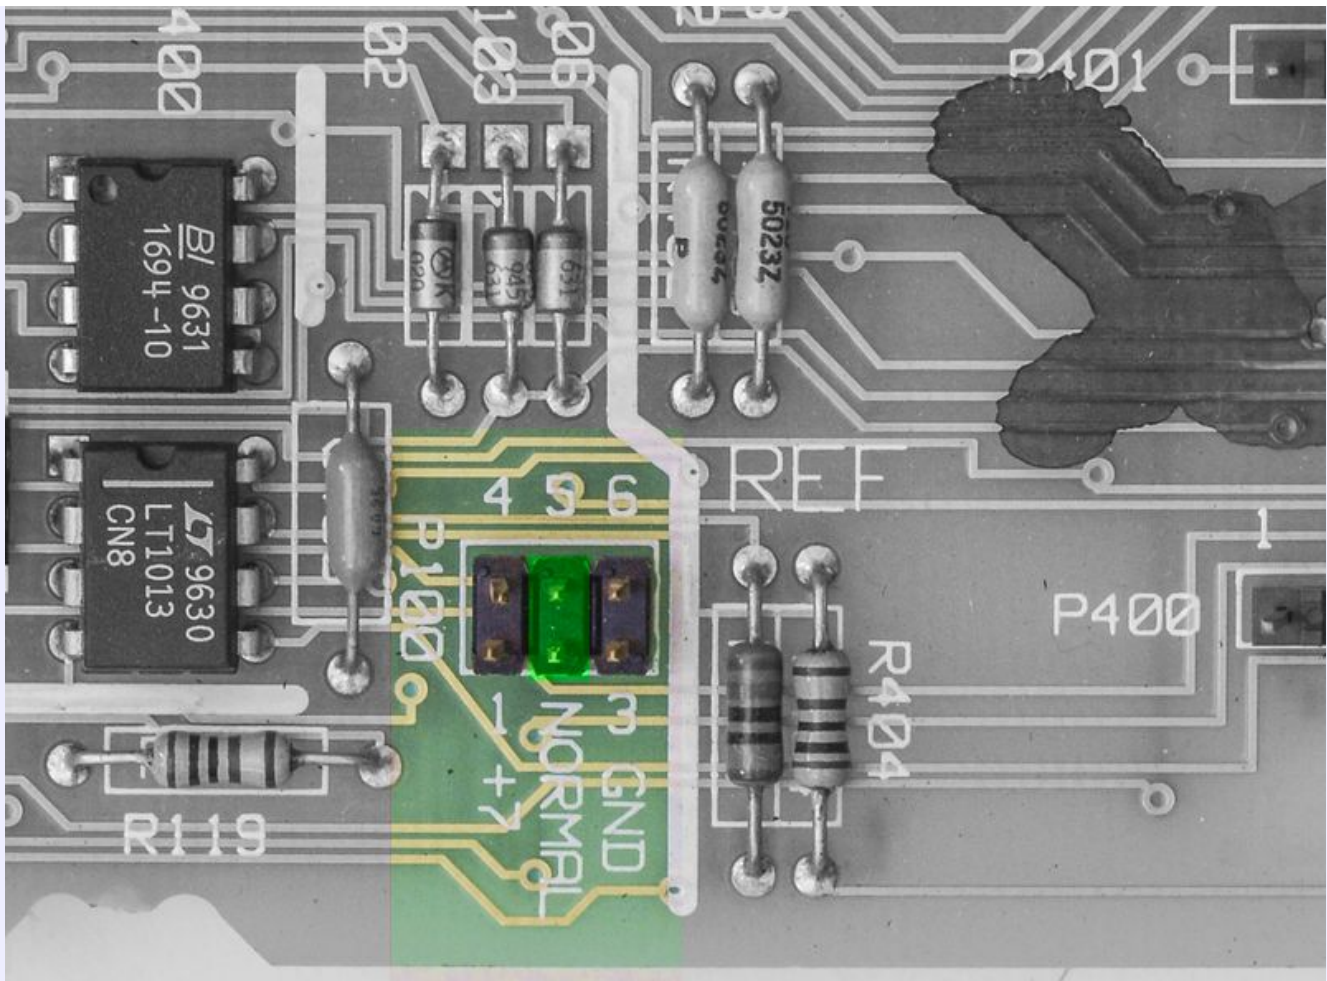
Issue was simply in missing jumper on A1 DC Board, which selects voltage reference input for rest of circuitry.

After installation jumper on position NORMAL, as marked in green on photo above – this error is gone, as well as meter's function on DCV, Ohms, ACV, frequency, period were recovered!

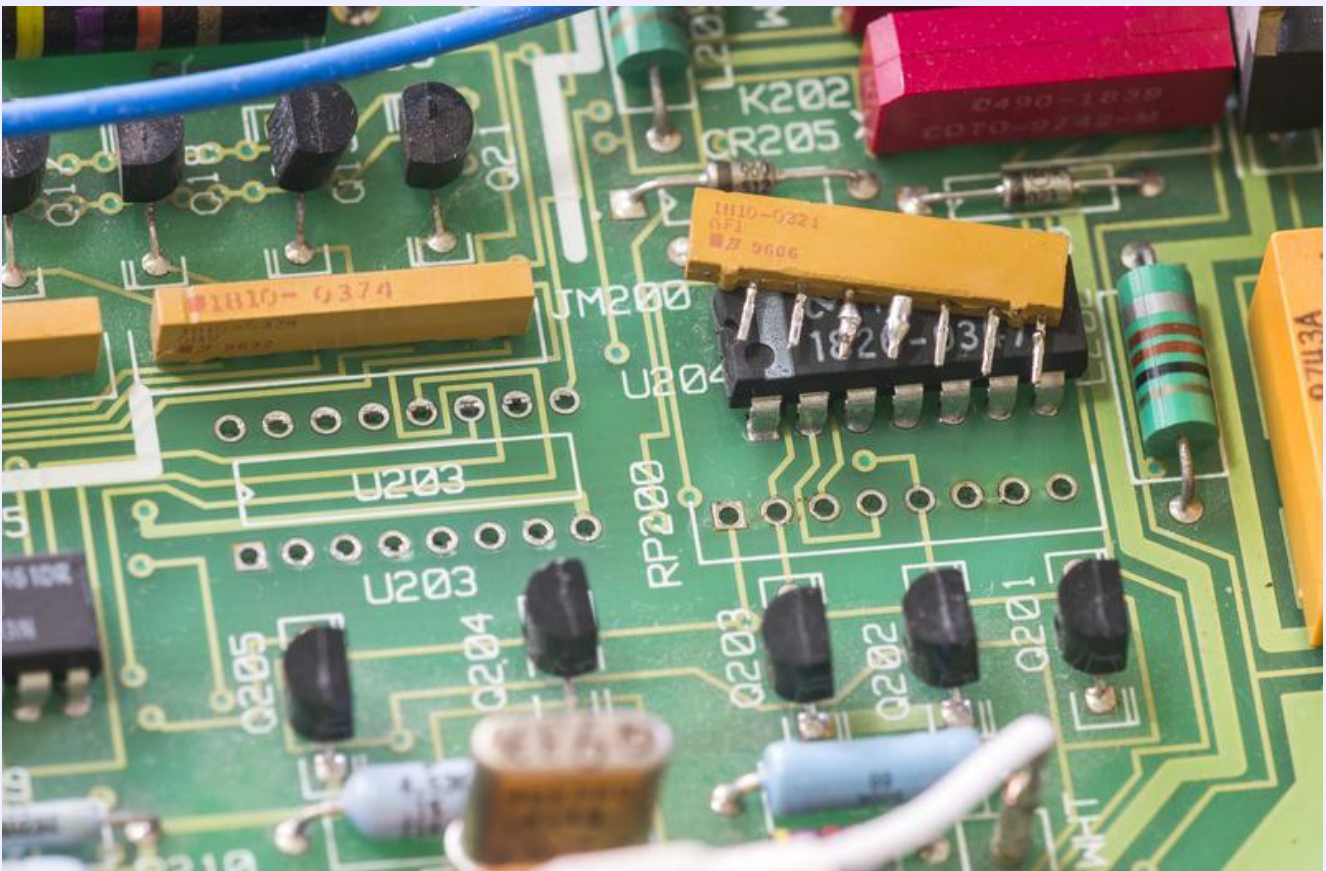
After removal both U203 and RP200, I quickly discovered issue. RP200 missing common pin 1 for resistor array! I don't know how that happen or what previous owner do to poor resistor. I replaced it with new 220Kohm 7-resistor SIP array. Worth to note, that schematics does show RP200 as pack of 100K Ω resistors, while BOM and actual A1 PCBA have 220K array installed. I used 220K, following original part resistance
