Intro

But today we will look on old unit, still wearing HP logo, manufactured somewhat in 1996. It was purchased as “parts, non-functional” piece for \$750 USD, which is below market price, even for broken meters. Perhaps you thinking “this guy is nuts, paying that money for 20 year old broken machine”. But think for a second, metrology-grade instrumentation market is very conservative. There are only 11 (eleven, that’s right) 8½-digit DMM models in the world, all vendors combined.

Let's see what we have to do to get unit back to operational state. My plan for this project is to perform full component level repair, and perform overall study of instrument's internal construction, as repair advances. This means we will not be doing expensive boards swap unless absolutely unavoidable.

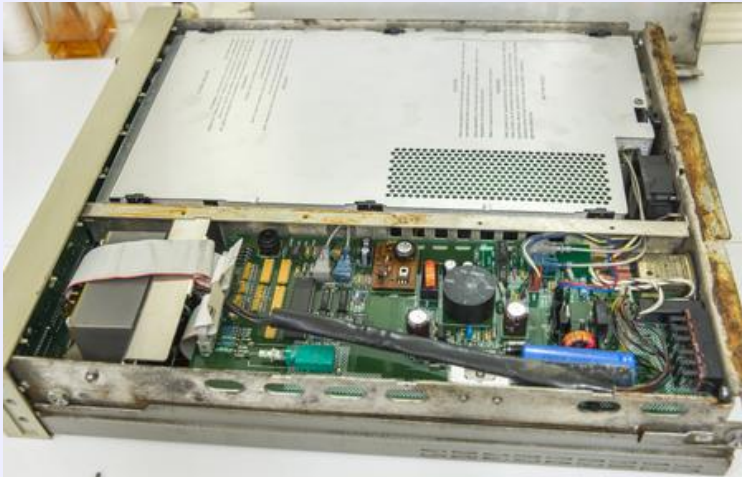
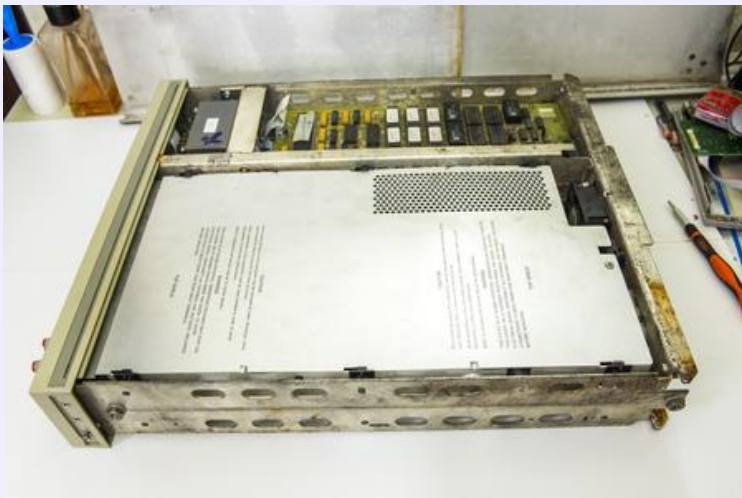
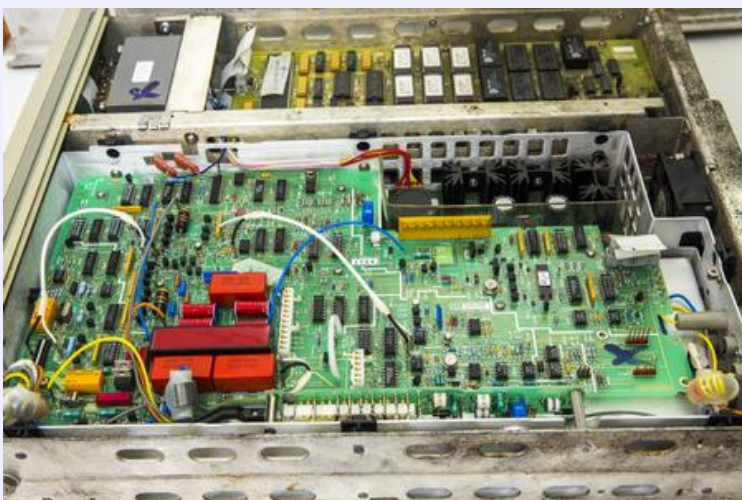
! Pay attention to mains voltage selection switches, located near mains IEC connector. Using incorrect voltage setting (e.g. 120VAC with 220VAC mains) will likely to destroy transformer, as it is linear type and directly wired to mains! This is likely what happened to my unit by

previous owner, and was a root cause of damage. New transformer cost is \$337 USD + tax, so was rather pricey mistake.

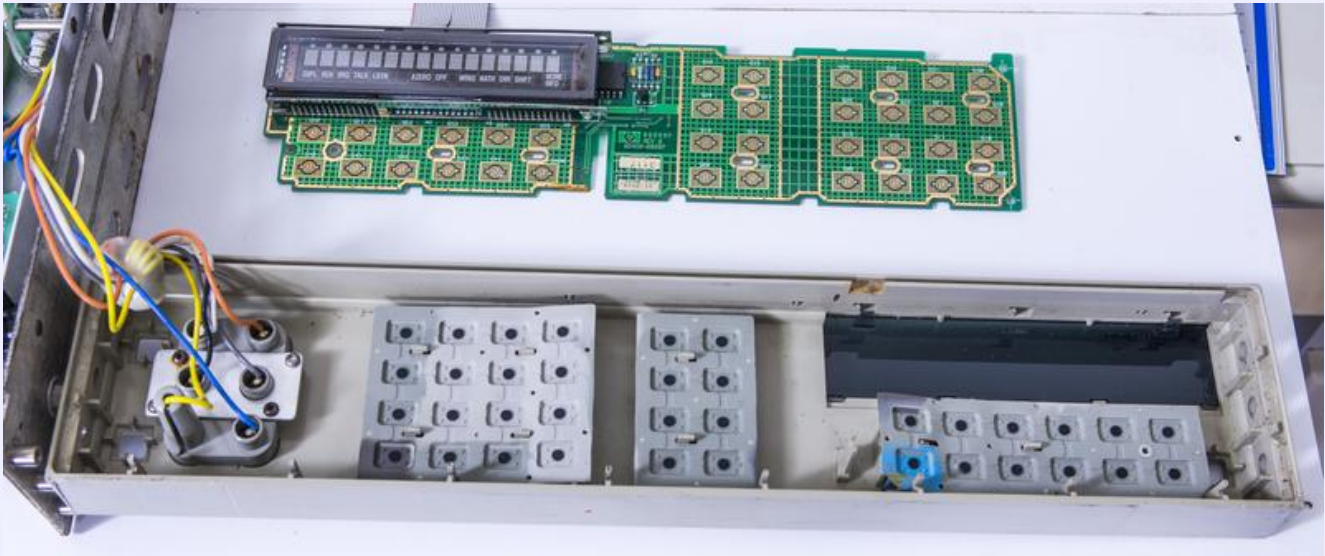
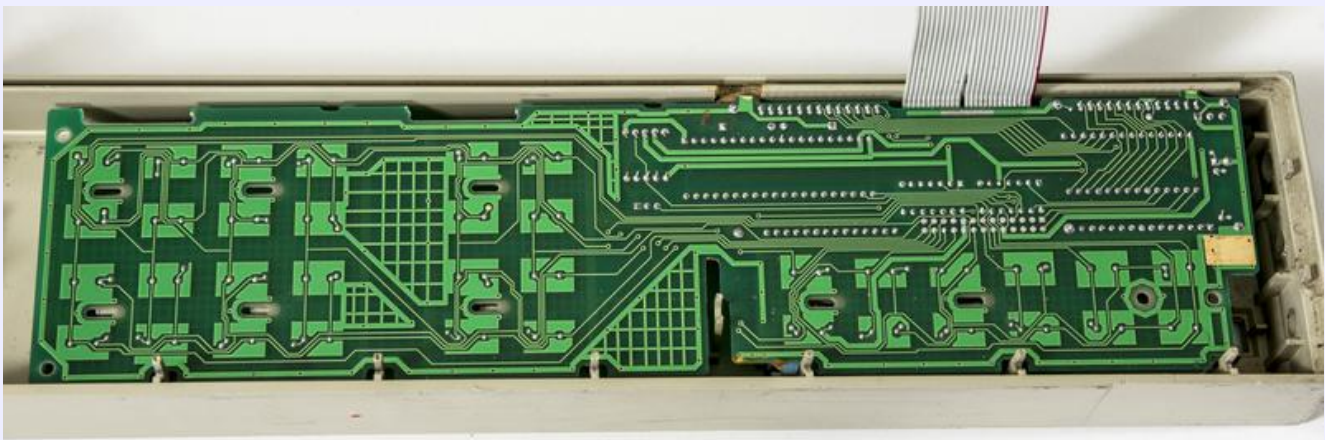
Looking good, just minor cleaning required..

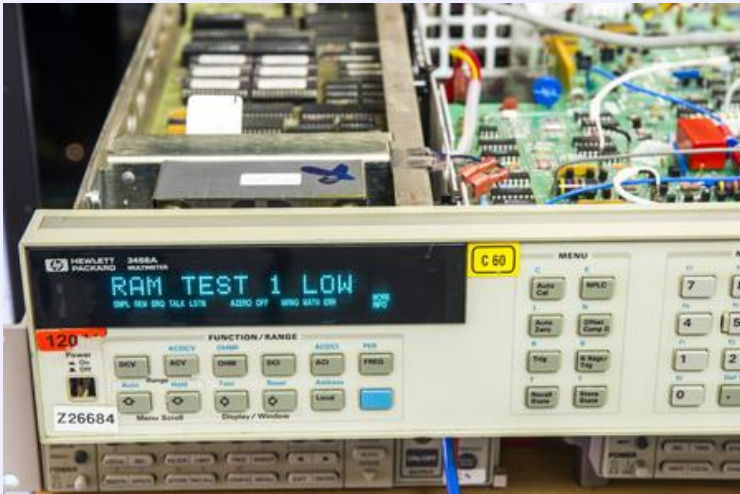
Display looks bright and nice, it's great news, as old VFD segments often fade badly if being operated for long periods of time.

Error message **RAM TEST 1 LOW** meaning there is fault with digital board. So let's troubleshoot digital section first, which is board A5. We will get into it later, let's finish up with A6 supply first.

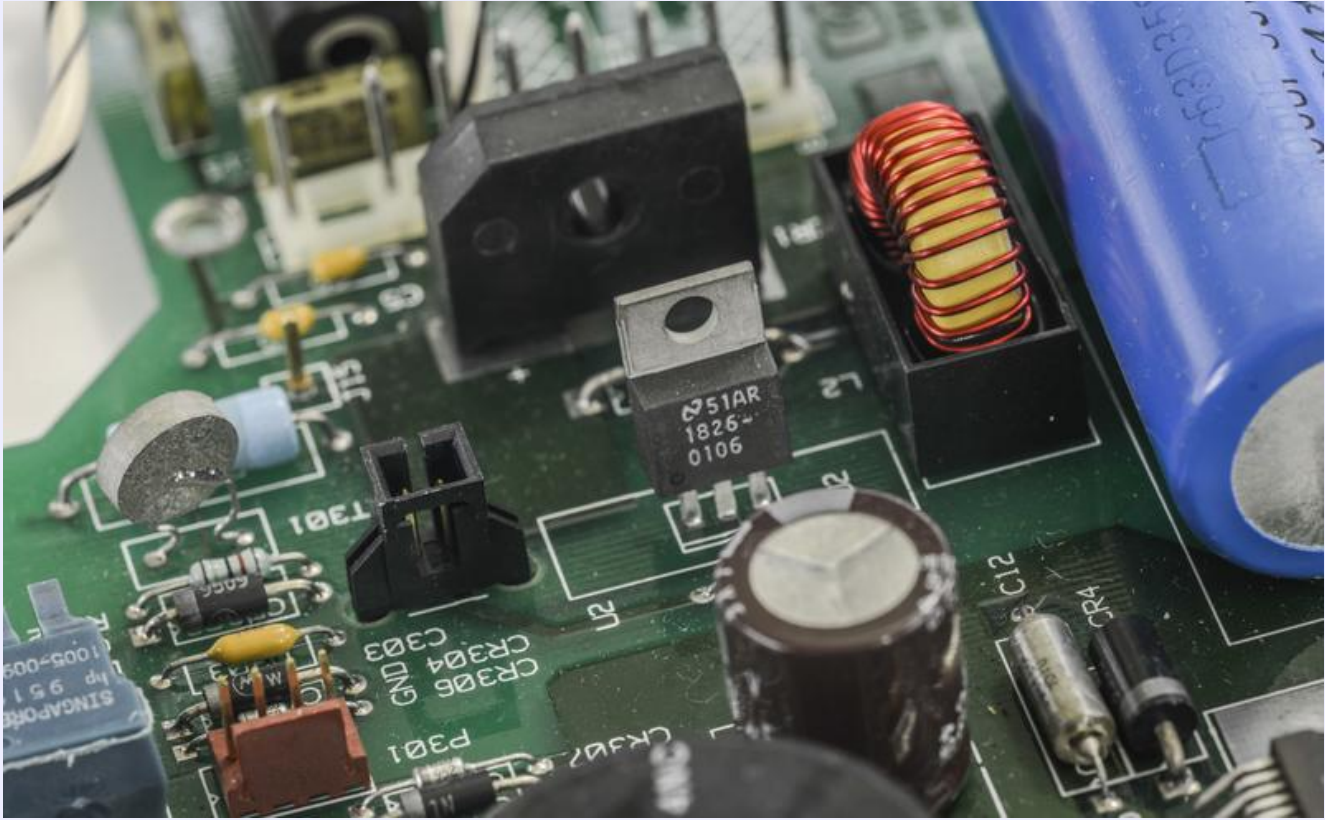
Black 2-pin connector at left of regulator is fan header. Fan in my unit is completely stuck and blocked by gunk, so instead of wasting time on fan cleaning, I'll just replace it with same spec'd new one from NMB.

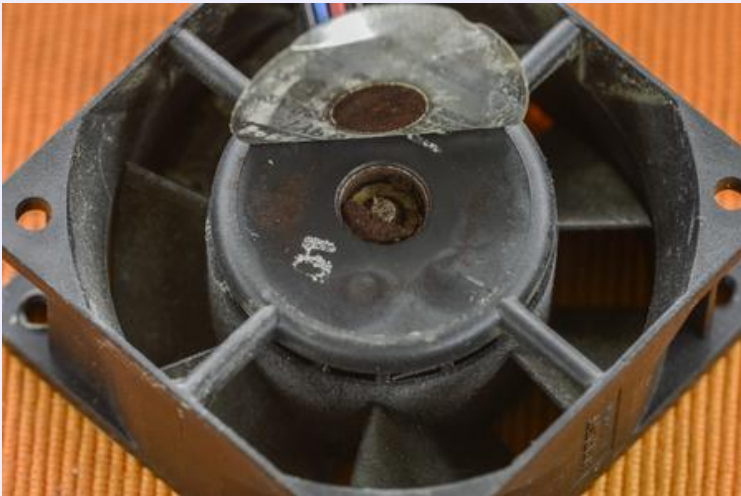
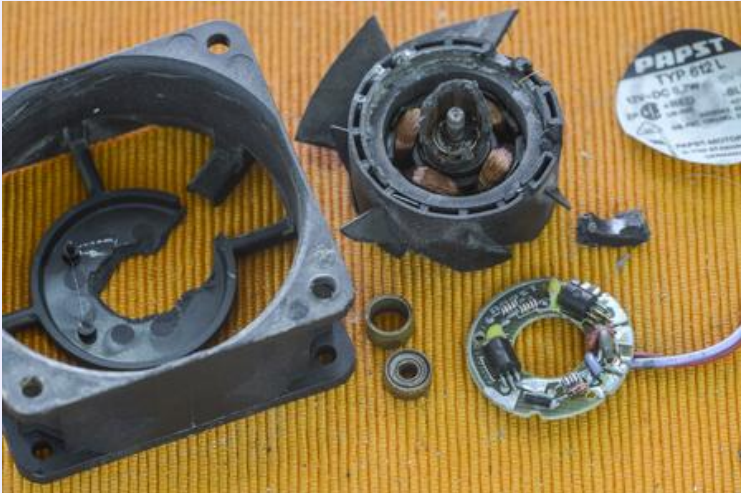
My favorite destructive analysis reveals fan support with dual ball-bearings. Lubricant was long gone, resulting metal-type dirt and specs in motor.

I desoldered original fan wire, so I'll use it with new fan, saving trouble with cable length and connector matching to A6 board.

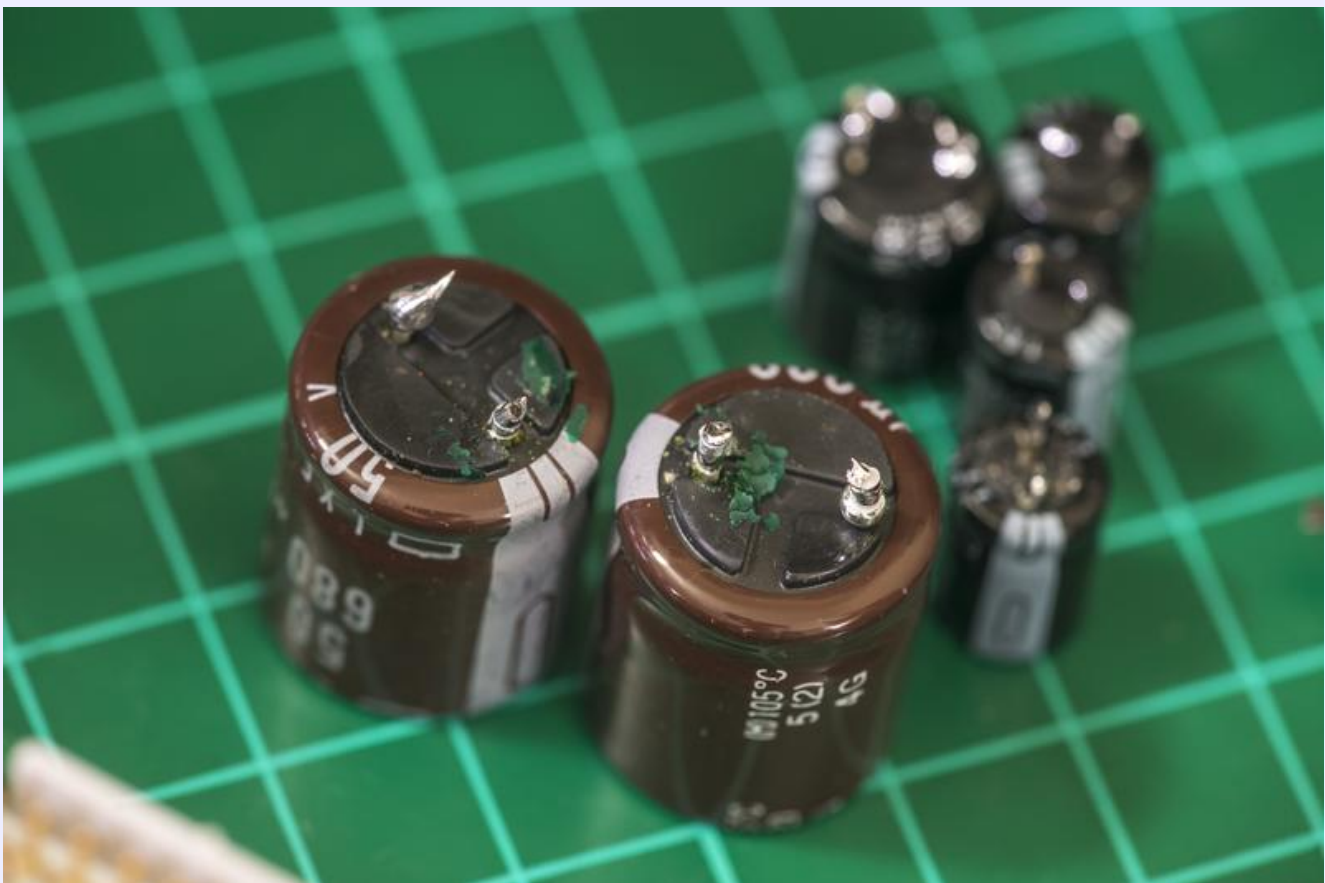
Now it's visible. Electrolyte got already out and started its destruction activities. Green pieces are actual PCB's solder mask.

Now I am really glad that we did not cut corners here, and removed them. And it's nice to have HP 3458A with only 2-layer PCBs, no risk of inner damages. I'll just clean it to shiny copper, add layer polyurethane enamel film around pins, just to be future-proof. Caps I bought from DigiKey are long-life, rated for +105°C, and so should work a treat for many years after replacement.

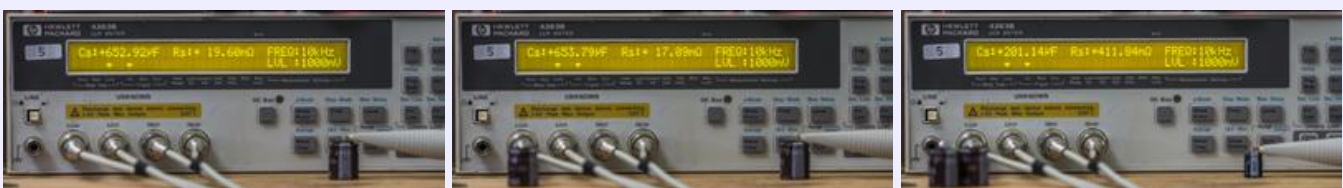
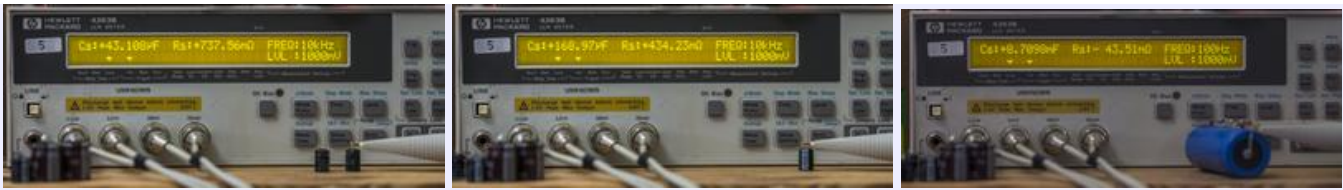
It's a good lesson, capacitors are only getting bad with age, not better as voltage references. 10 years passed? Replace them **now!**

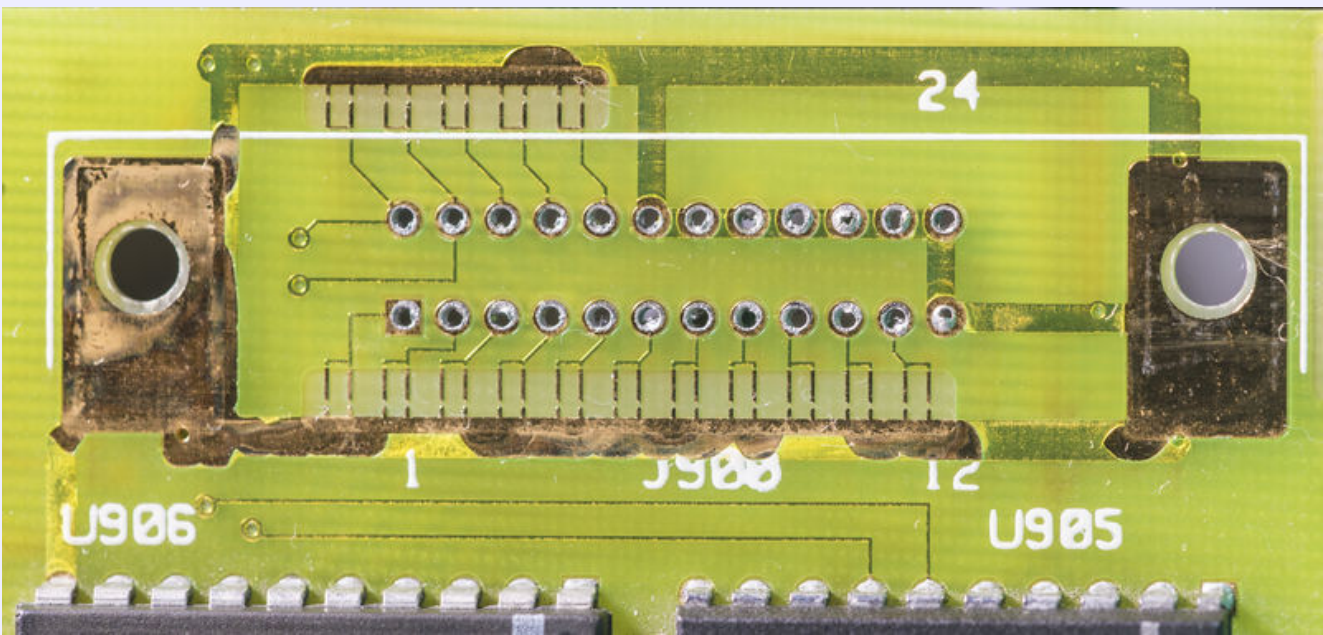
My board also fall within range of [Service note 3458-13A : GPIB Communication Failures Using the 3458A](#), so I will add jumpwire for better ground on GPIB connector. There is interesting open connection routing with open mask on top side of PCB, just near connector pins.

I also replaced GPIB connector, as original one is really rusty. New GPIB connector was used from [broken HP 33120A PCB](#).

After connector replacement (had to saw it a bit, as it's mounted to PCB using rivets!). No, I don't have a drill, so used hand mill instead.

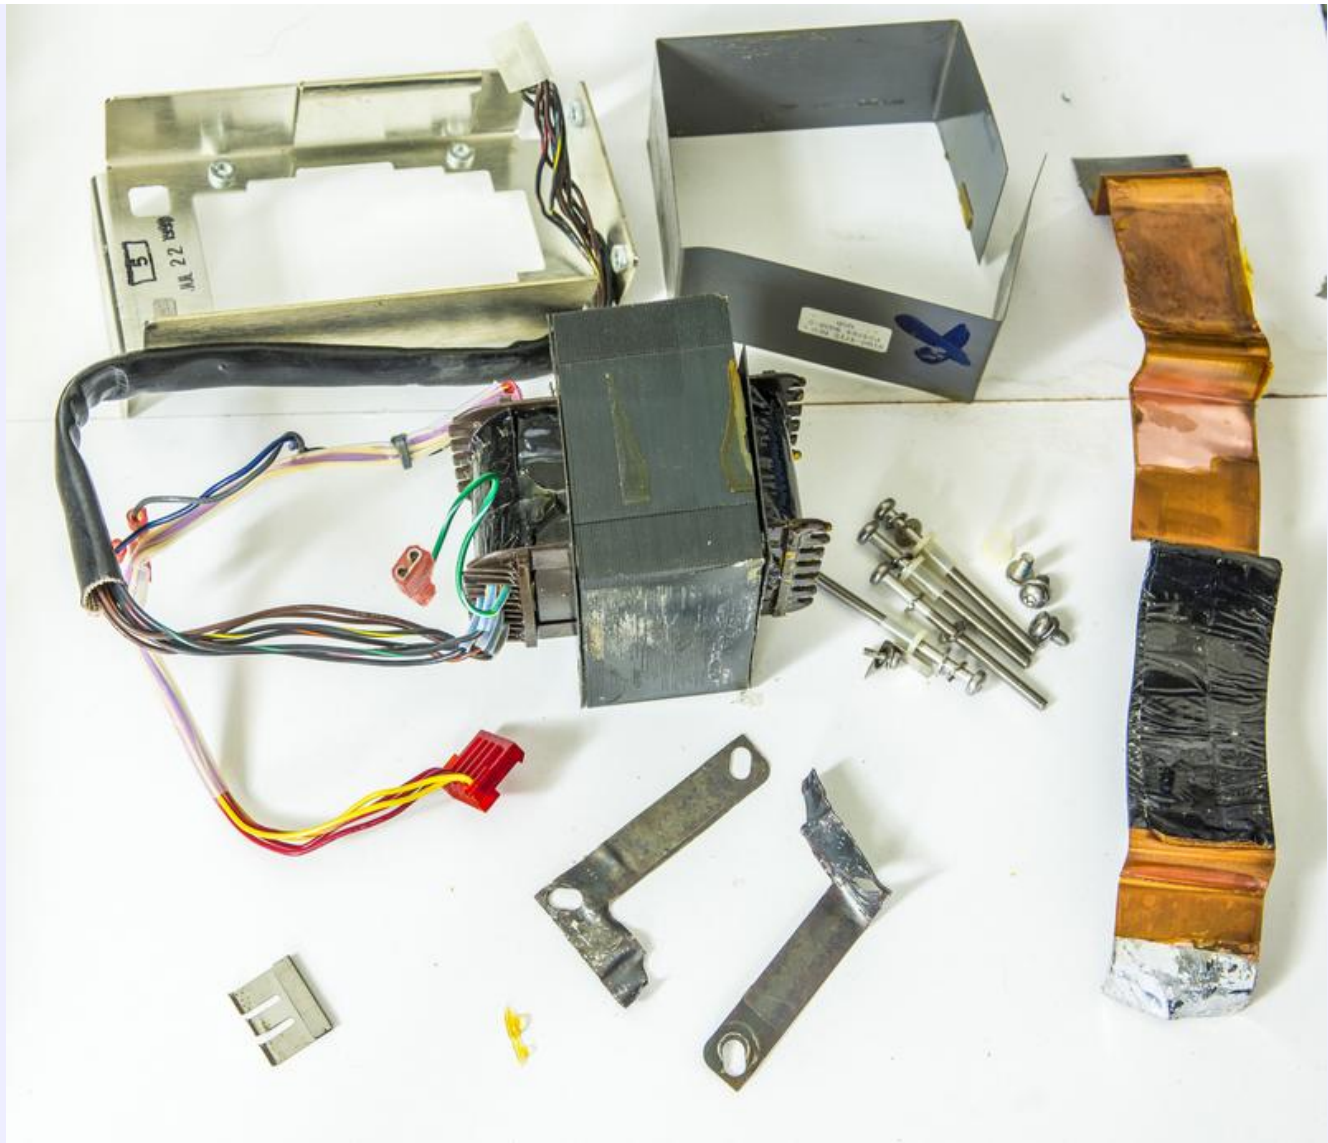
Transformer have winding sections, with separate two bobbins, primary with secondary Outguard +5V rail (goes to digital board and front panel, so that's working).

Second section for Inguard supply is inner bobbin with two secondary windings (one with center tap to generate +18/-18 and second for +5V analog supply).

Each winding have its own metal inner shield to reduce leakage and coupling between different transformer sections. Each of those shields have separate wire connected to different locations at Outguard and Inguard chassis frame points.

I would not trust repaired/rewinded transformer in such an instrument anyway, so we going to make Keysight richer for \$337. That's new transformer cost.

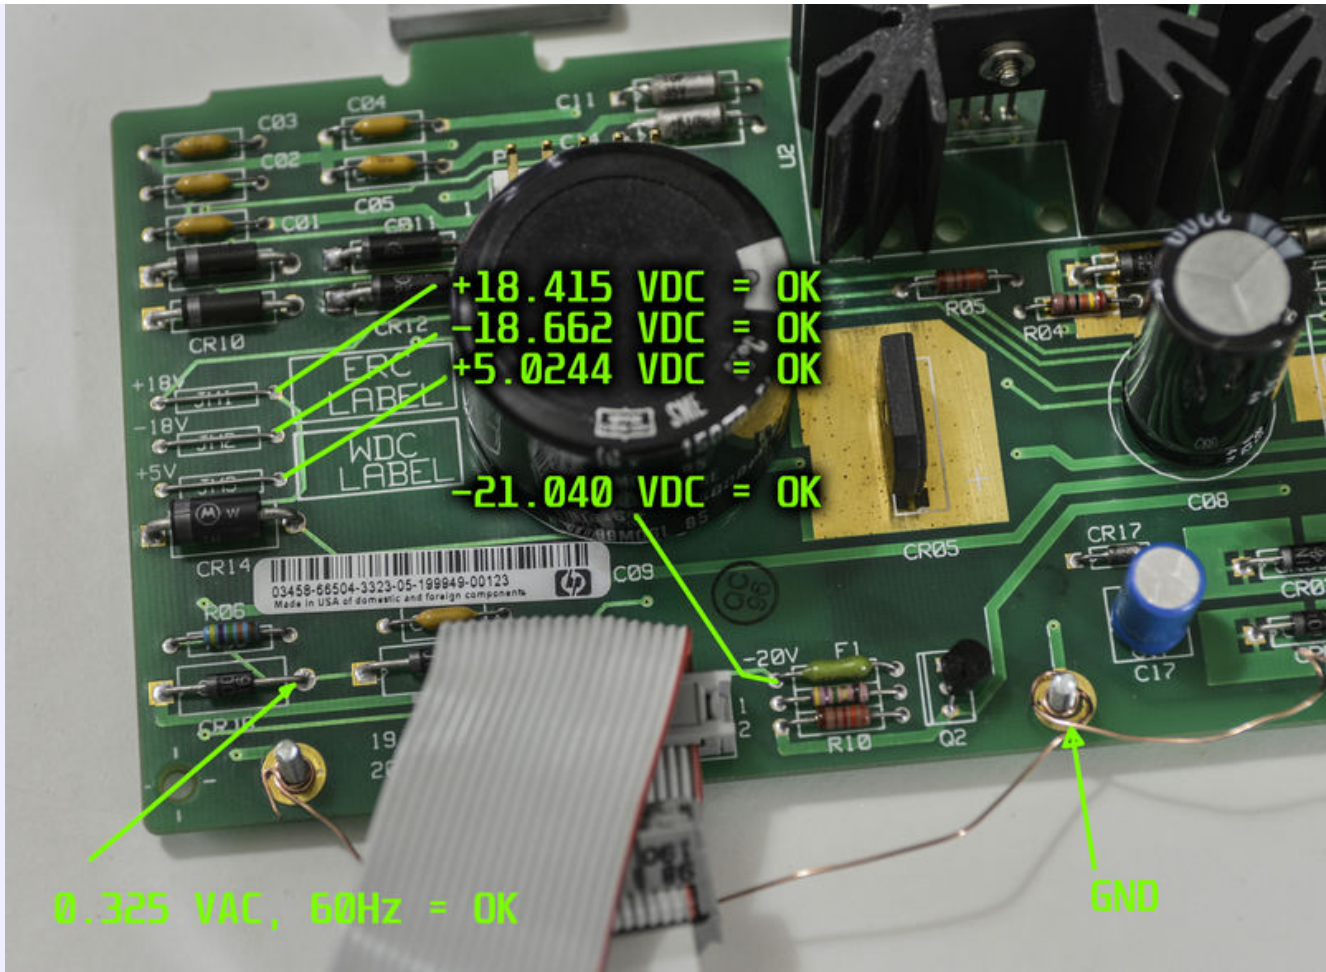
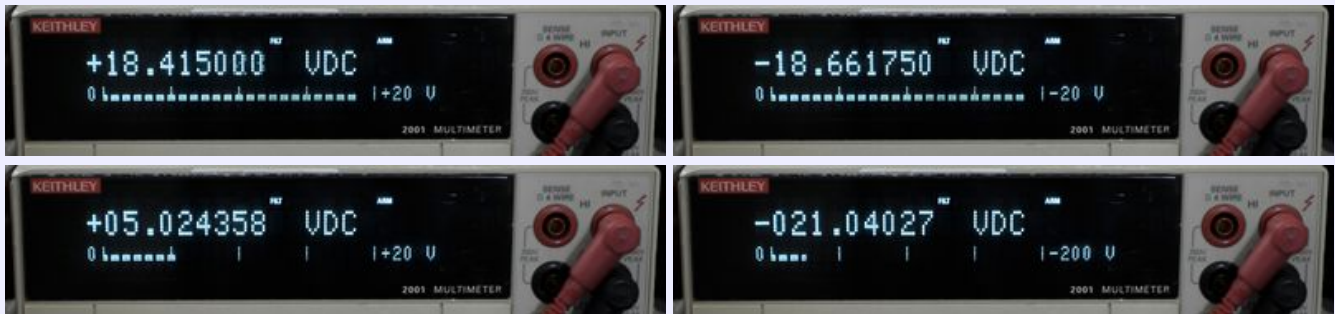
There are nice labels near test points, telling us voltage test points location.

All voltages are OK, also 0.325VAC 60Hz signal to read mains frequency is OK too.

I also replaced 2200MFD 35V and 15000MFD 16V electrolytic capacitors to 2200MFD 35V & 27000MFD 35V (did not find stock of 15000MFD in proper size).

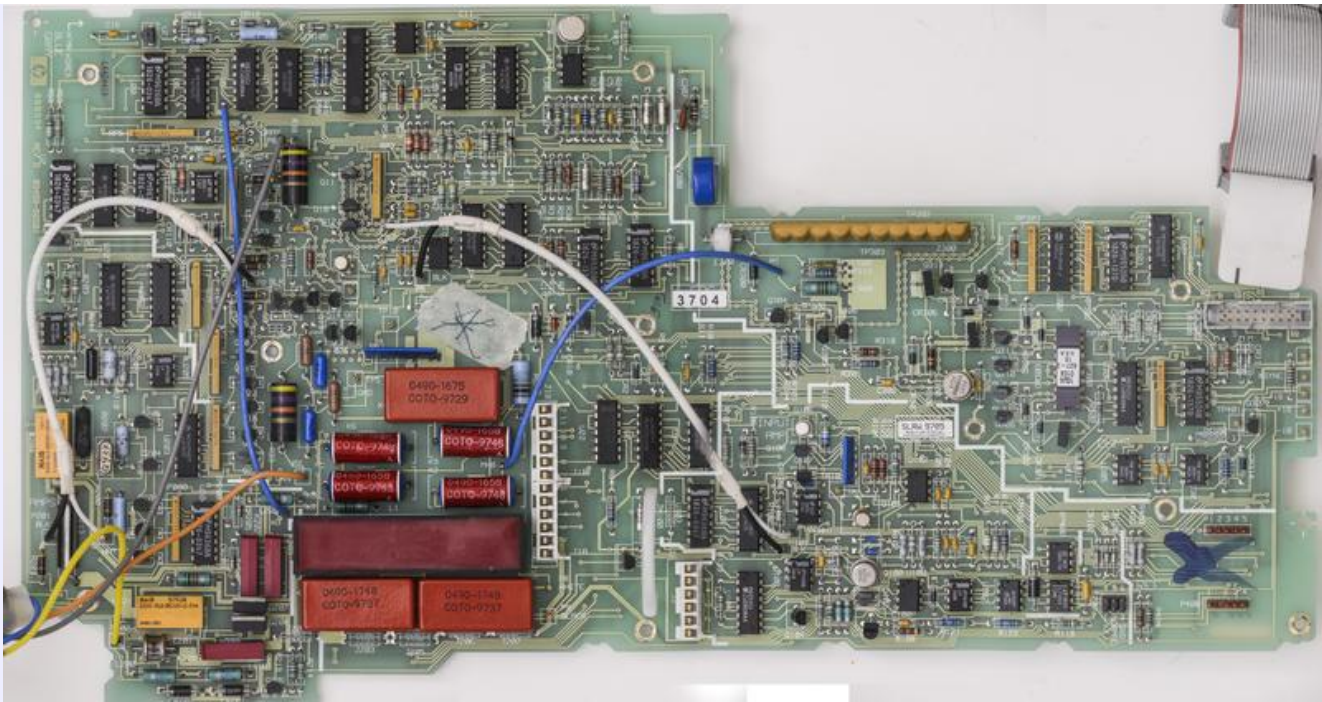
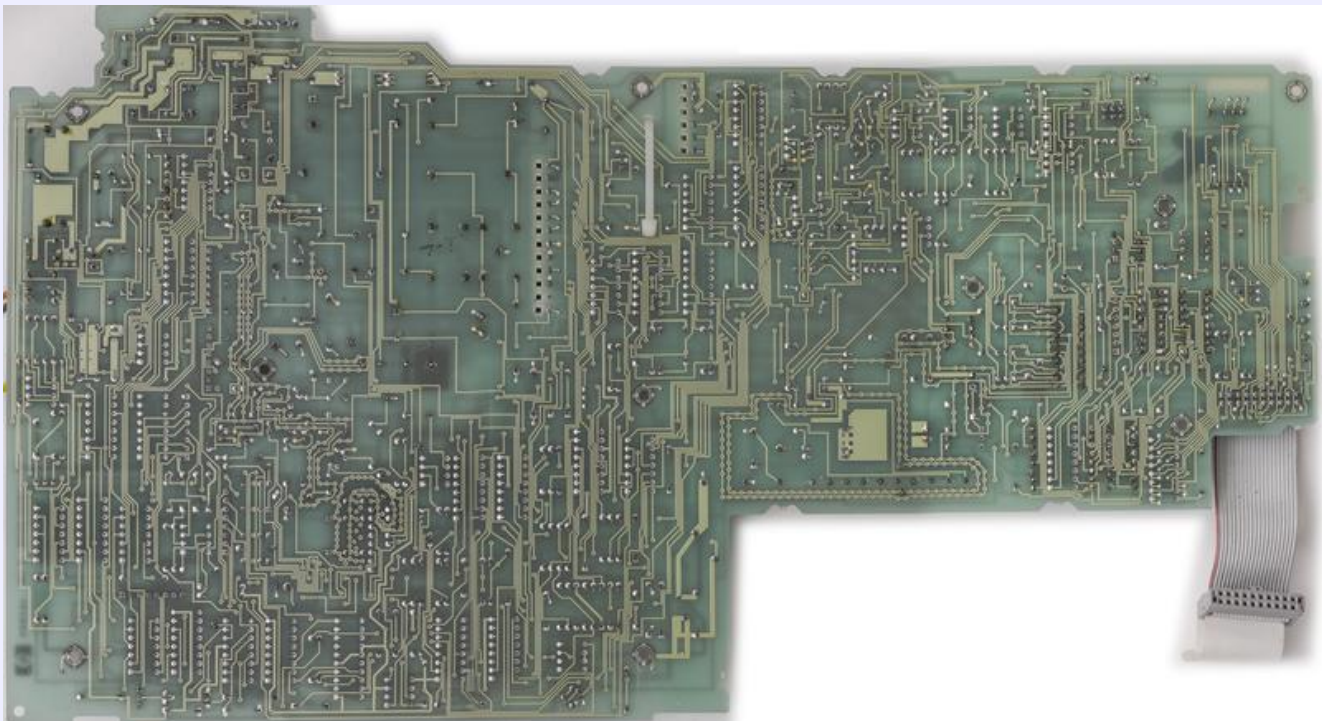
This board also have mark "X" around reference header, also paper tape sticker "X" in center of board near RP7 resistor network. Visual inspection shows ugly soldering and flux around parts U300, U305, U301, RP300, U304, U306, RP301, U303, RP302, RP303, R308, R307, R310, RP200 and around all relays (K1, K2, K3, K4, K5, K6, K7, K9, K200, K201, K202, K203, and K204). Relays have date codes from 1997, while rest of the board IC's dated 1995-1996. Previous owner tried to fix board by replacing relays?

Looking not good, if you ask me. That's why even broken gear sold by inexperienced owner, without attempts of non-qualified repair is easier to restore than hardware which looks mint externally, but have solder bodes and flux all over the field inside. Oh well, let's continue.

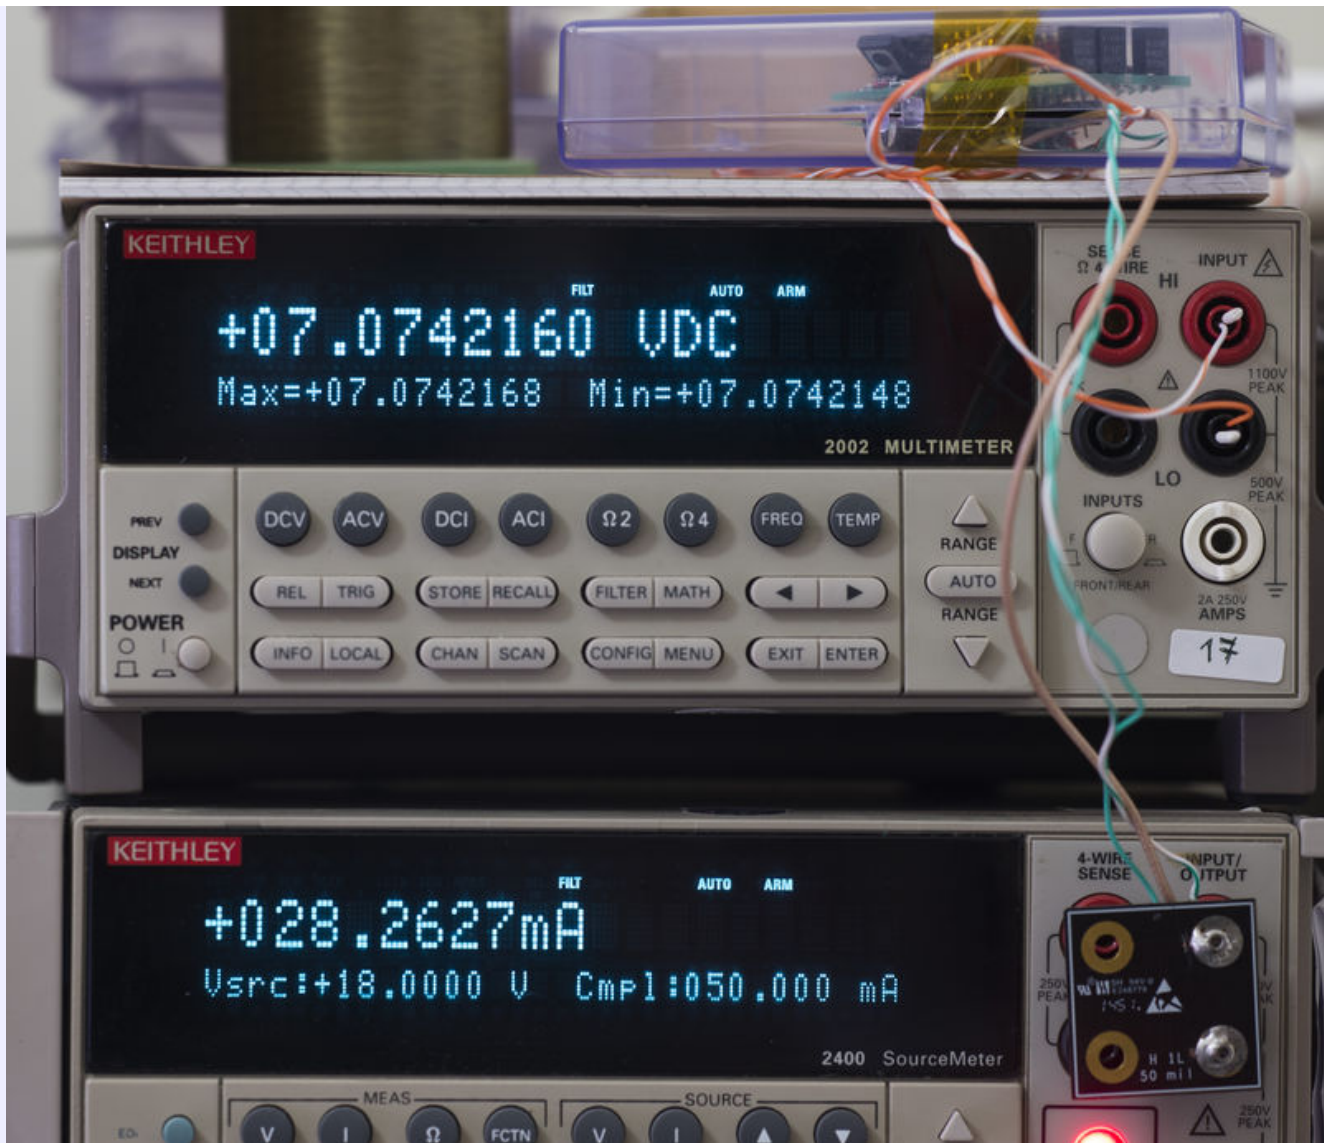
After prompt warm-up, reading stabilize around $+7.07421 \times \text{VDC}$, with $+26.5 \text{ }^\circ\text{C}$ ambient temperature. My 2002 is few $\sim 30\text{ppm}$'s low compared to calibrated 2001, so real voltage just a bit higher. Point here is, that our DCV reference board is operational and can be installed into 3458A without second doubt.

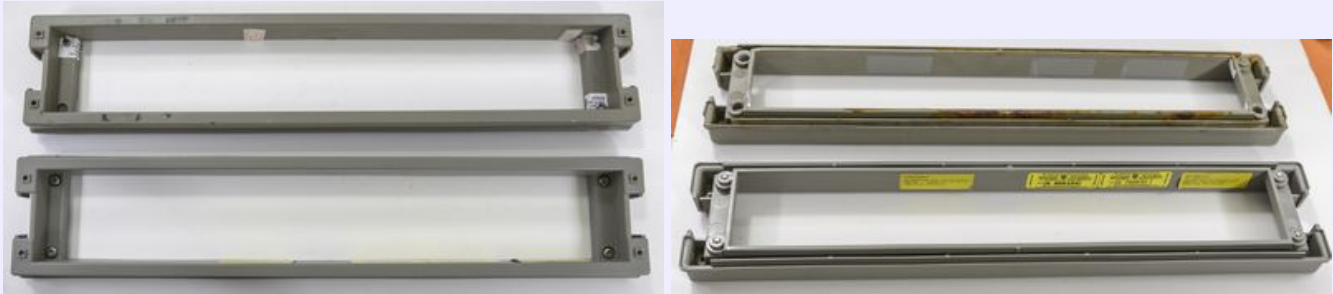
Original unit's bezel had three out of four screw mounts destroyed, so it was not holding well.

I got used bezel off eBay in good condition, to save some money on this project, as it's just mechanical part to keep meter in one piece. New one on bottom side, old busted rear bezel is on top:

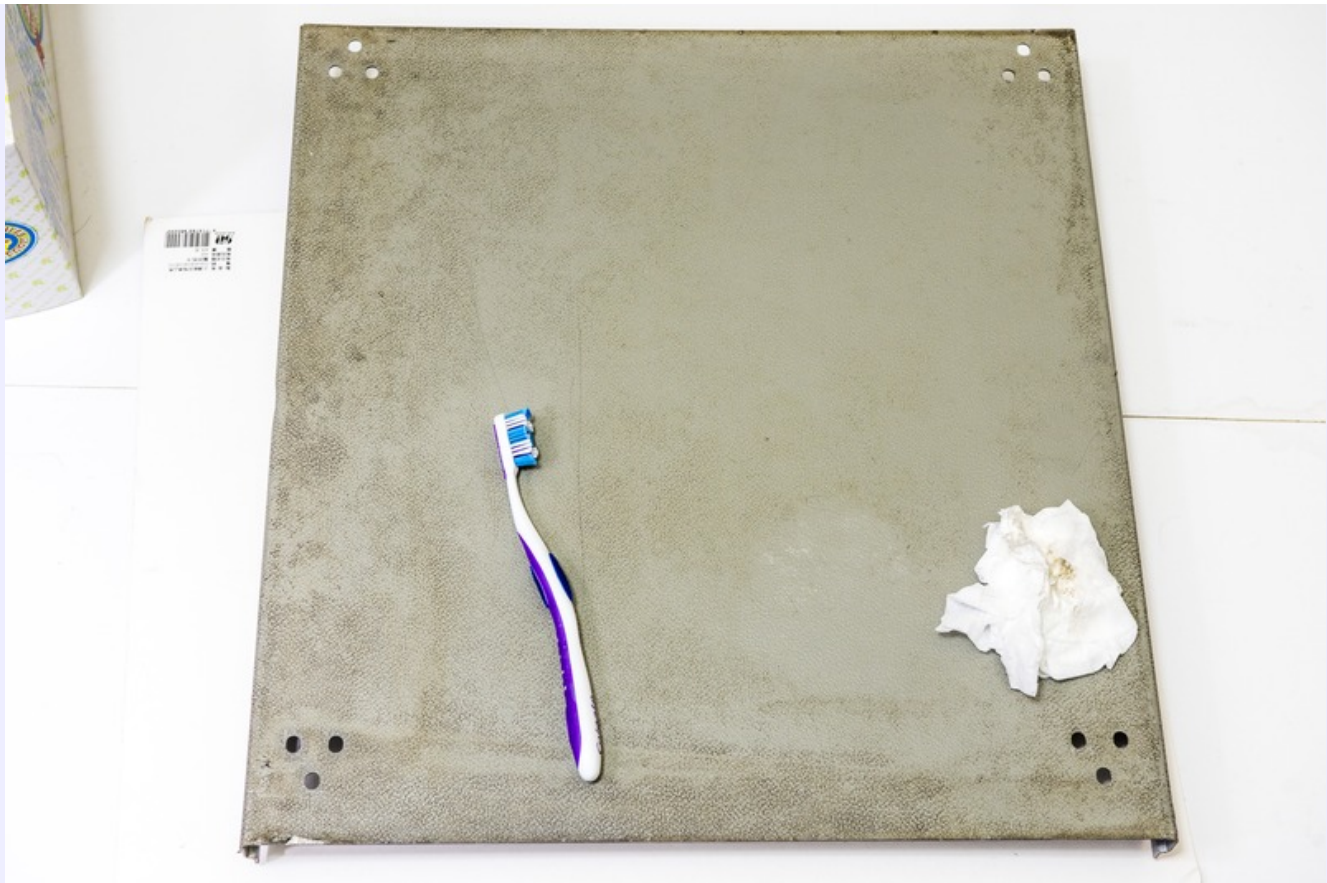
Dirty and nasty, but nothing is hopeless, with help of **3M Scotch-brite** and half a bottle of alcohol (not drinking, like some might thought!), everything is possible.

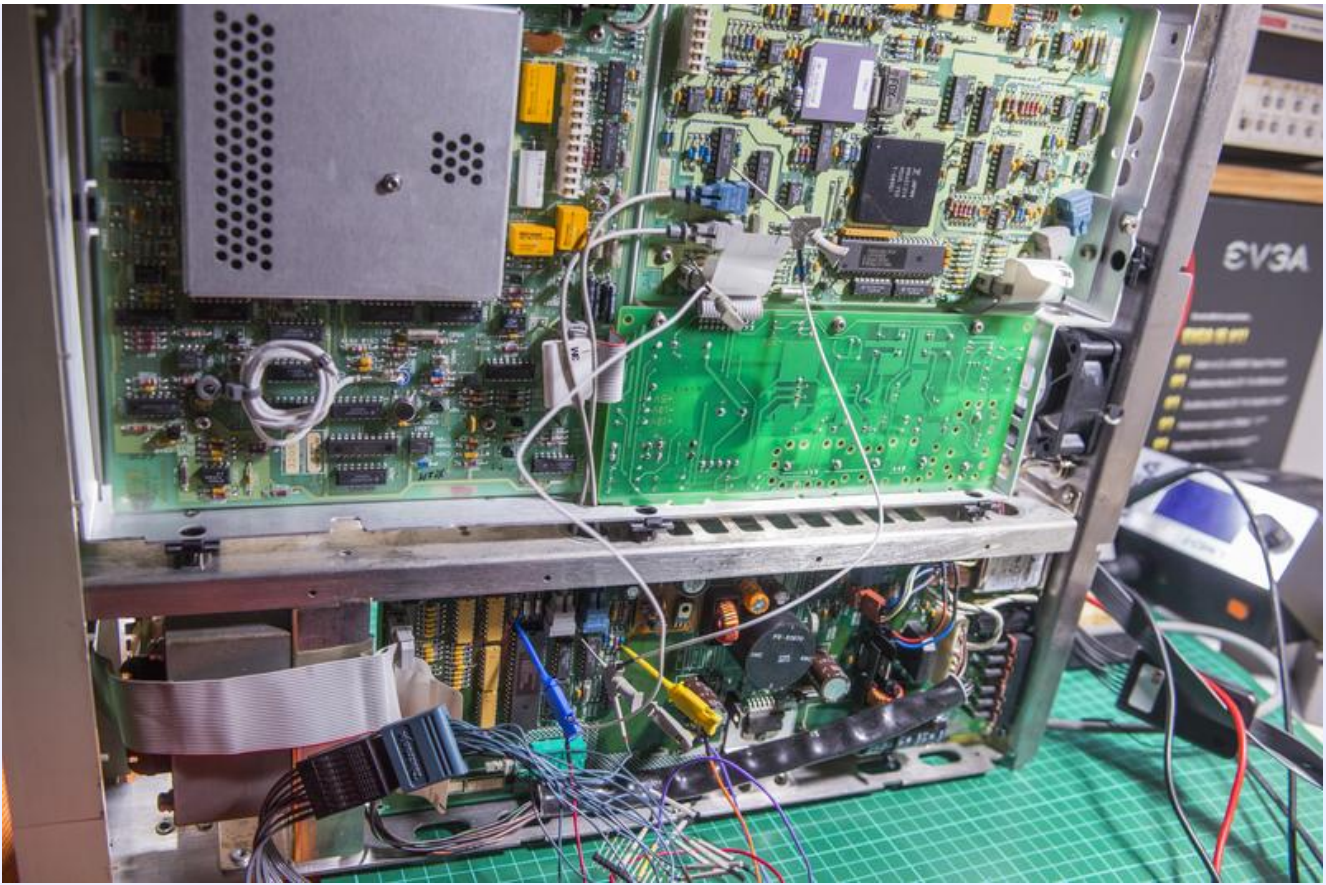
One thing I notice before, LED light on J102 is really dim, could be also show actual problem with transmitter diode. Since it was easy, I actually swapped J102 with J303 before (which used for external triggering BNC ports), but result was same, so could be both transmitters are faulty.

Transmitters and receivers are orderable from DigiKey, they are [Avago HFBR-1521Z](#) and [HFBR-2521Z](#). Cable assembly is available as well, [DigiKey 516-2090-ND for 1m](#)

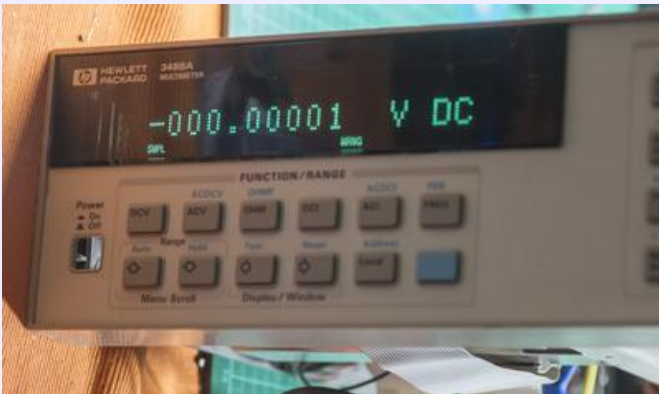
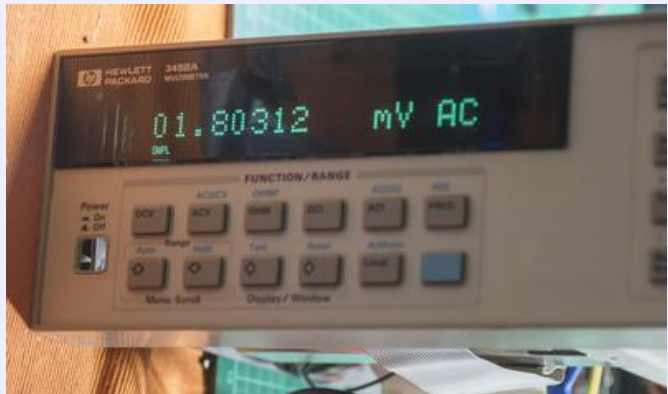
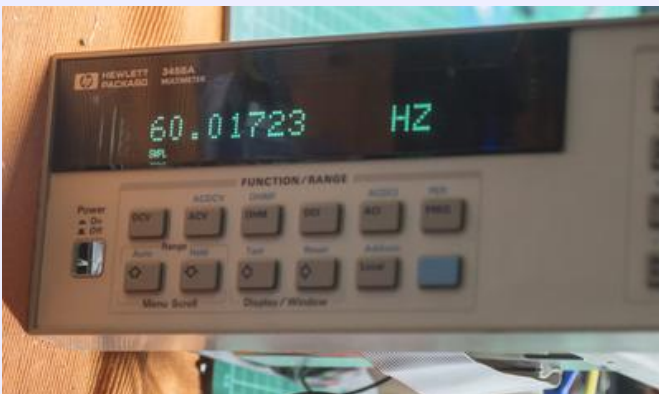
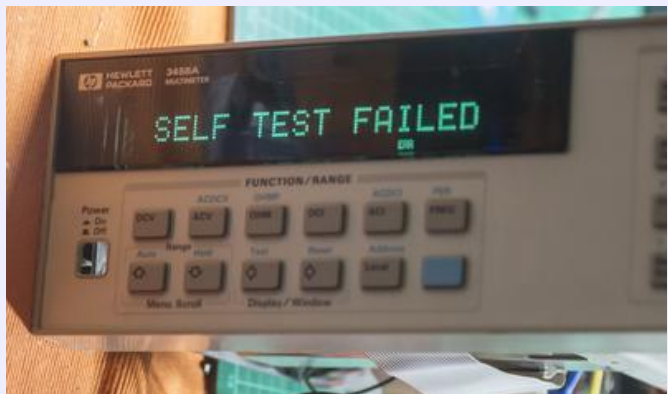
It does lit up ERR with next errors:

202, "HARDWARE FAILURE — SLAVE TEST: CONVERGENCE"

If I try run ACAL ALL, it says **205, "HARDWARE FAILURE — CAL VALUE OUT OF RANGE: 72"** which is DCV A1 value, as per ALRM document.

To test this I had bypass transmit isolation path by adding a shorted between anode of A6 CR101 diode to U302 pin 9 input on A3 A/D board. Guess what, it booted and let me to UI.

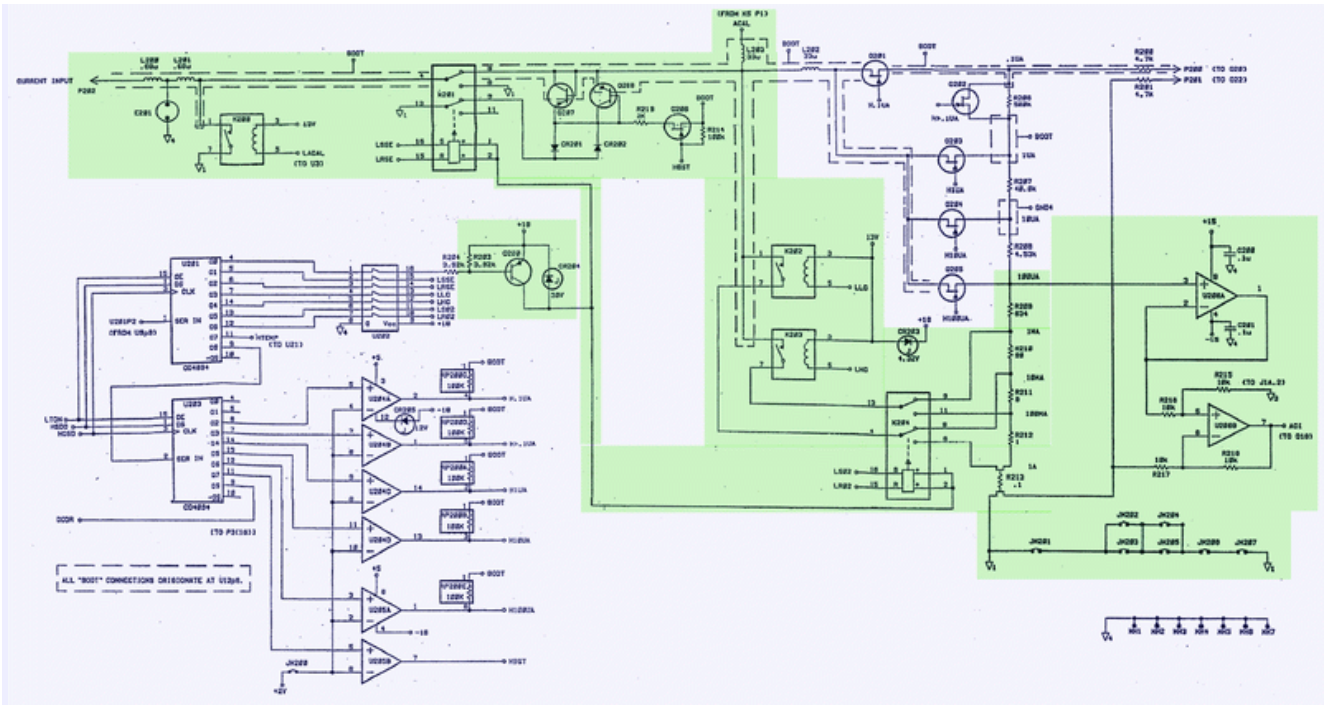
Further diagnostics revealed that low current ranges on DCI are not working, reading around zero current, disregarding actual current on input.

This is also confirmed by failure in self-test and ACAL: **205, "HARDWARE FAILURE — CAL VALUE OUT OF RANGE: 95"** which is DCV gain for 10μA value, as per ALRM document.

Since ranges 1mA and more working ok, we can rule out R210,R211,R212,R213 current shunt path, as well as input relays K201,K202,K203.

After removal both U203 and RP200, I quickly discovered issue. RP200 missing common pin 1 for resistor array! I don't know how that happen or what previous owner do to poor resistor. I replaced it with new 220Kohm 7-resistor SIP array. Worth to note, that schematics does show RP200 as pack of 100K Ω resistors, while BOM and actual A1 PCBA have 220K array installed. I used 220K, following original part resistance

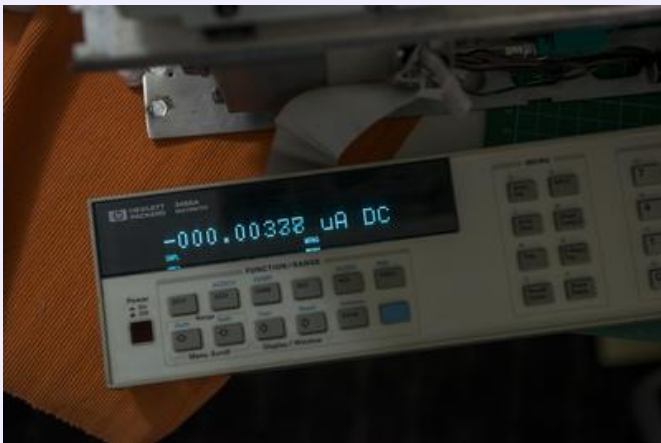
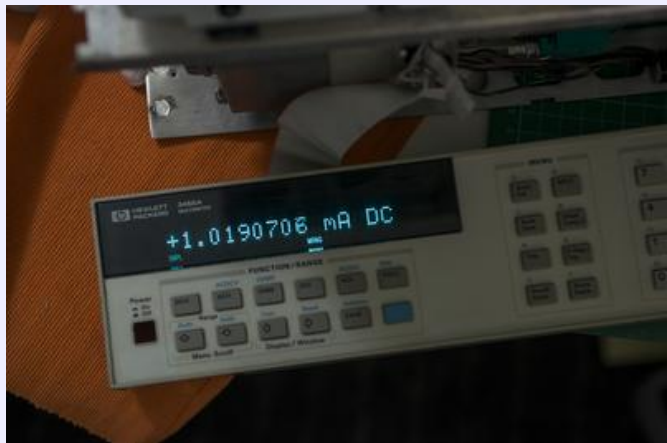
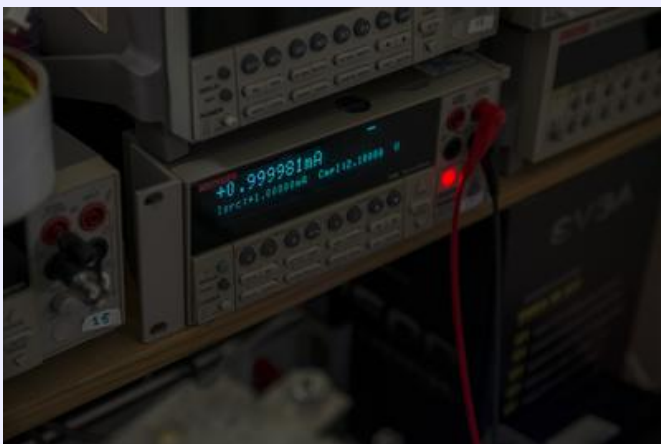
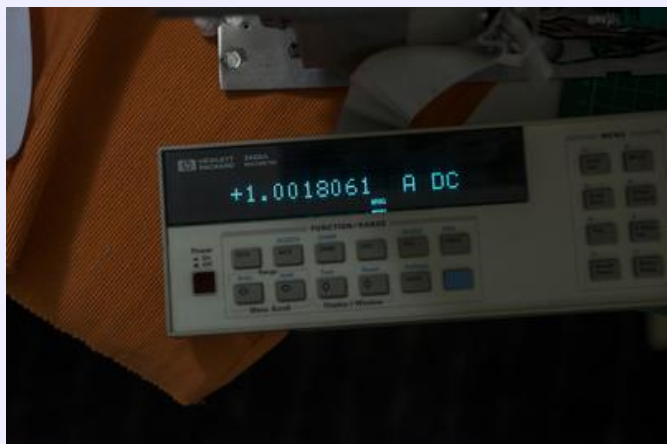
It is not likely that issue to be damaged JFET switches Q201-Q205 for low-current shunts R209-R206, as it's less probable that all of them died.

So I will test control circuitry first, which consists of U204 and U205 LM339 comparator for level shifting, U203 4094 shift register and RP200 generic resistor network and CR205 zener.

One thing we know from initial inspection – resistor network RP200 was resoldered by previous owner. I have bought RP200 replacement before, just in case, so it could come handy.

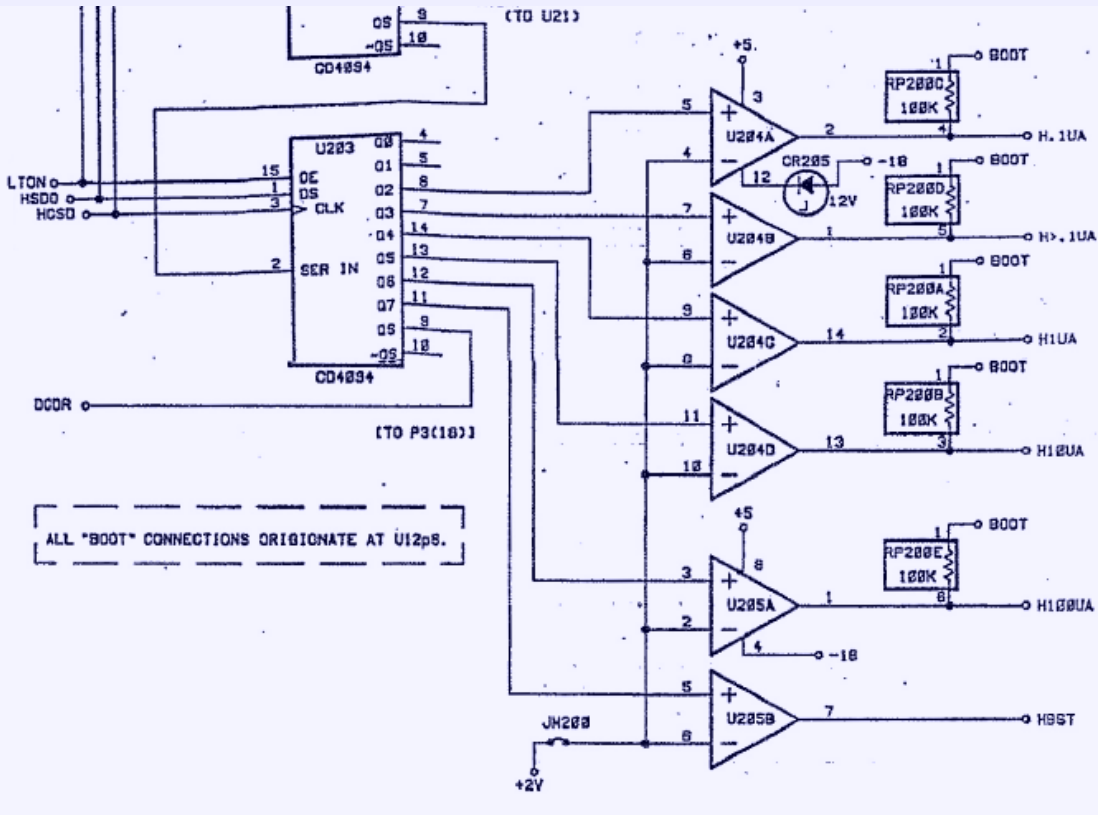
RefDes	Part type	Digikey ID	Test result
RP200	Resistor network, 8-SIP 220K Ω x 7pcs		Replaced
U203	Shift register, serial in, parallel out, 8bit, MC14094BCP		Replaced
U204	Comparator, LM339N, Selected		OK
U205	Comparator, LM393N		OK
CR205	Zener 12V 5% 0.4W, TC $\pm 0.077\%$, 1N963B		OK
