Intro

But today we will look on old unit, still wearing HP logo, manufactured somewhat in 1996. It was purchased as “parts, non-functional” piece for \$750 USD, which is below market price, even for broken meters. Perhaps you thinking “this guy is nuts, paying that money for 20 year old broken machine”. But think for a second, metrology-grade instrumentation market is very conservative. There are only 11 (eleven, that’s right) 8½-digit DMM models in the world, all vendors combined.

Let's see what we have to do to get unit back to operational state. My plan for this project is to perform full component level repair, and perform overall study of instrument's internal construction, as repair advances. This means we will not be doing expensive boards swap unless absolutely unavoidable.

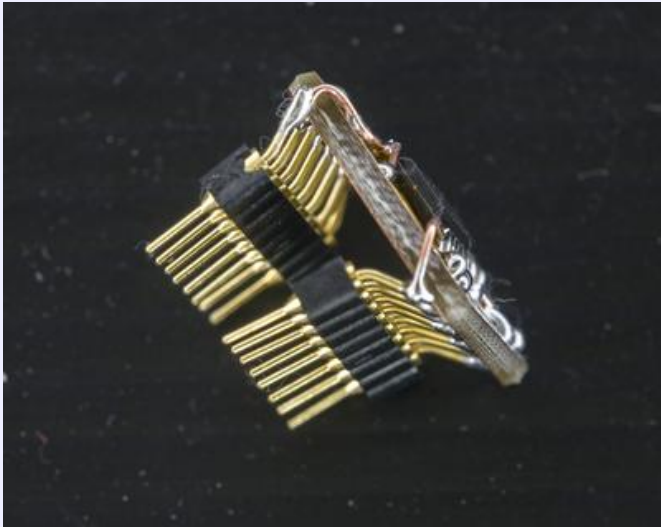
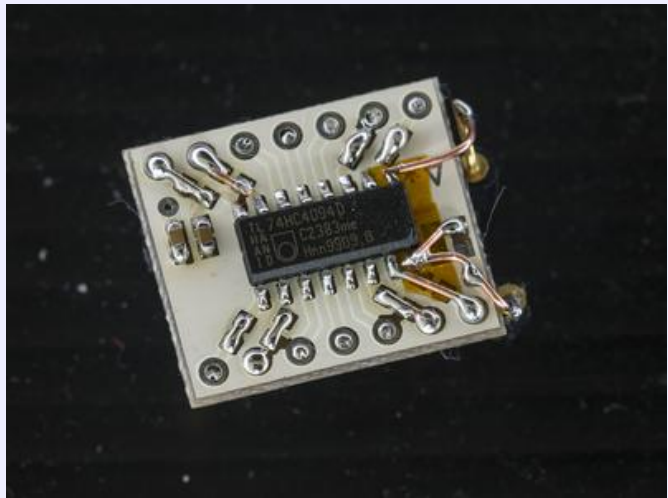
After removal both U203 and RP200, I quickly discovered issue. RP200 missing common pin 1 for resistor array! I don't know how that happen or what previous owner do to poor resistor. I replaced it with new 220Kohm 7-resistor SIP array. Worth to note, that schematics does show RP200 as pack of 100K Ω resistors, while BOM and actual A1 PCBA have 220K array installed. I used 220K, following original part resistance

I quickly made bodge for 4094 U203 :

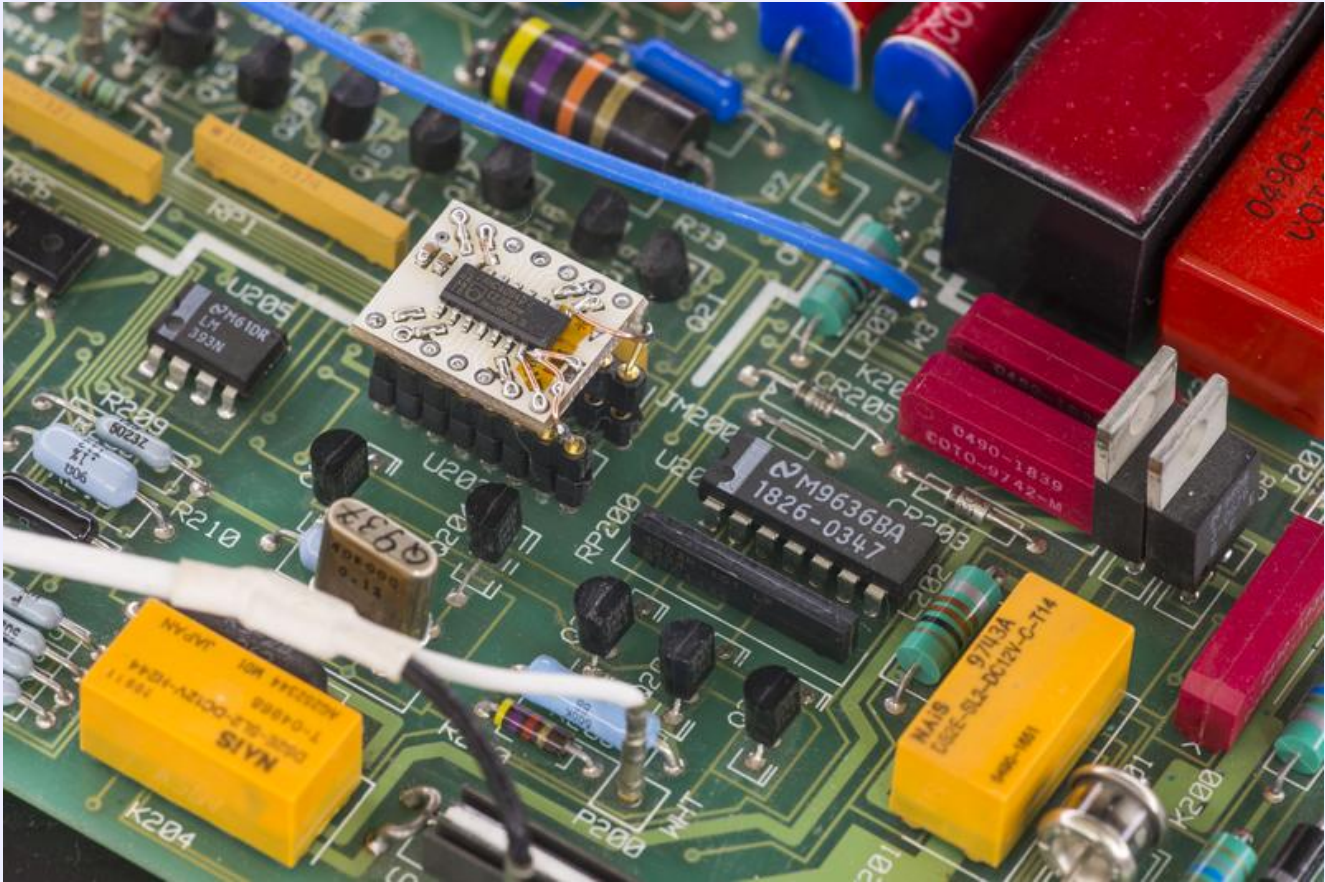
And it did, no problems on low current ranges anymore.

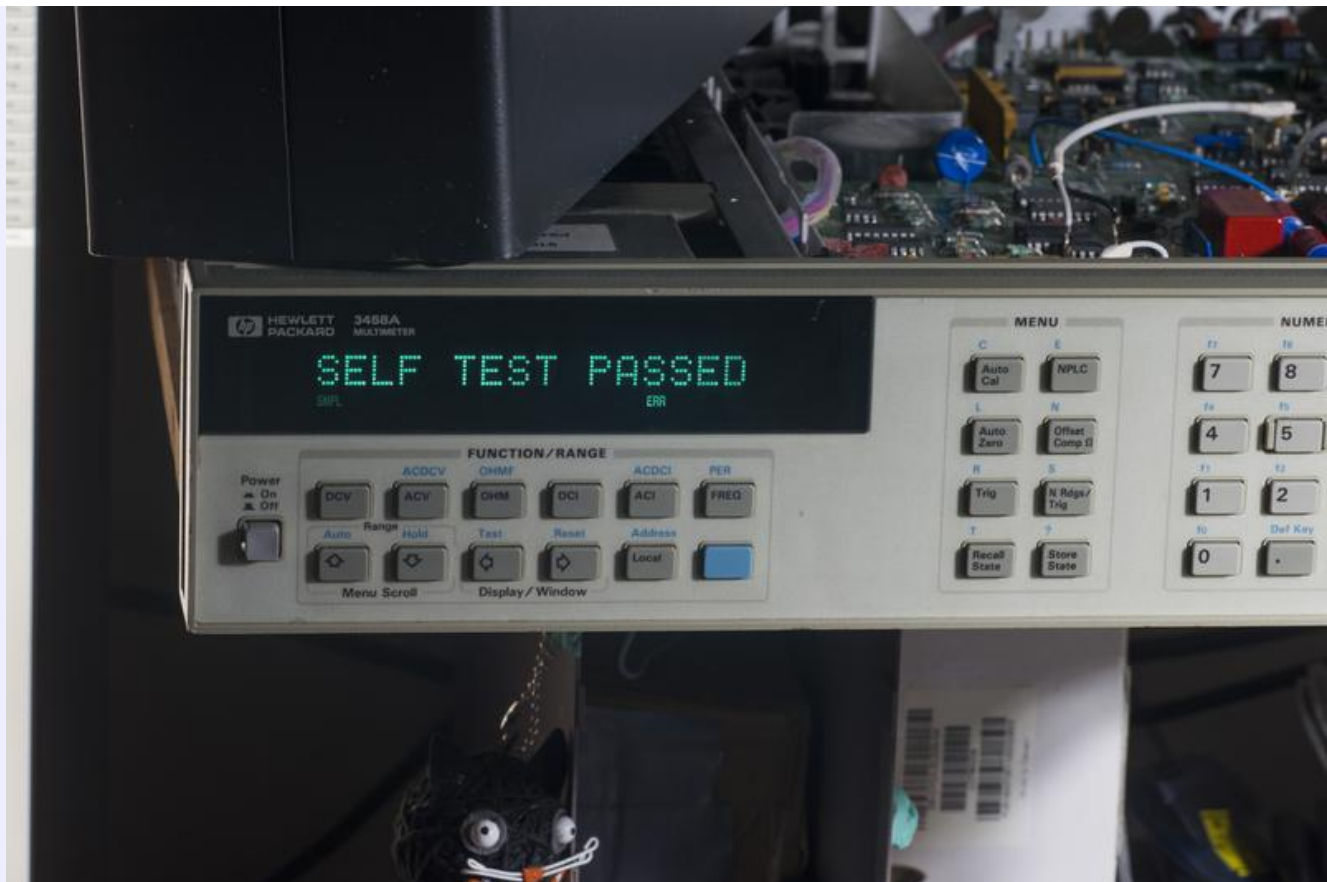
Unit also does complete whole selftest diagnostics. Very happy to see this **SELF TEST PASSED** message after all the work we had done above. Now left to do is overall assembly and make sure everything is secured and nice.

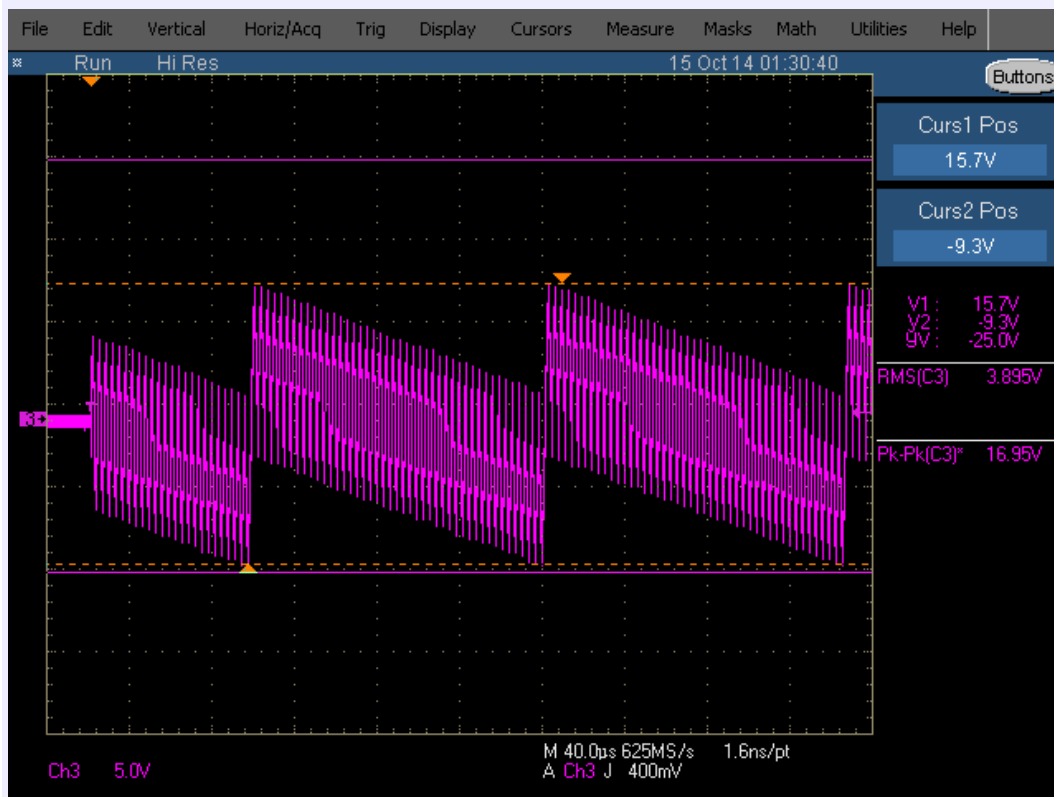
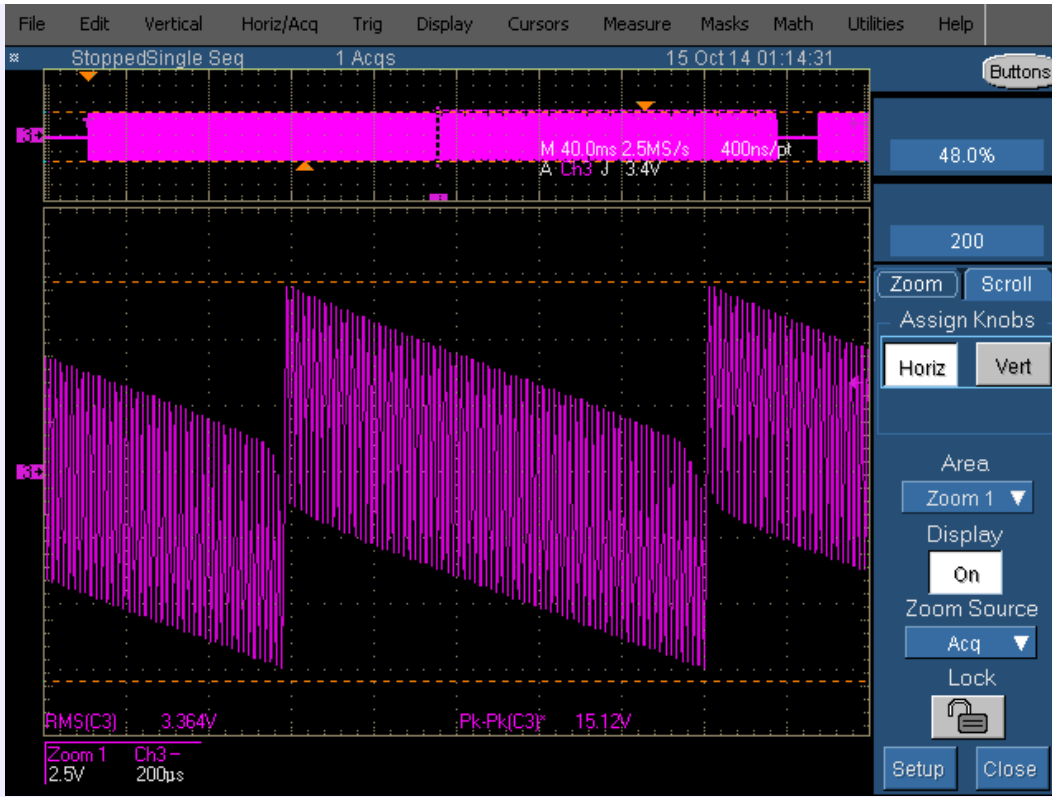
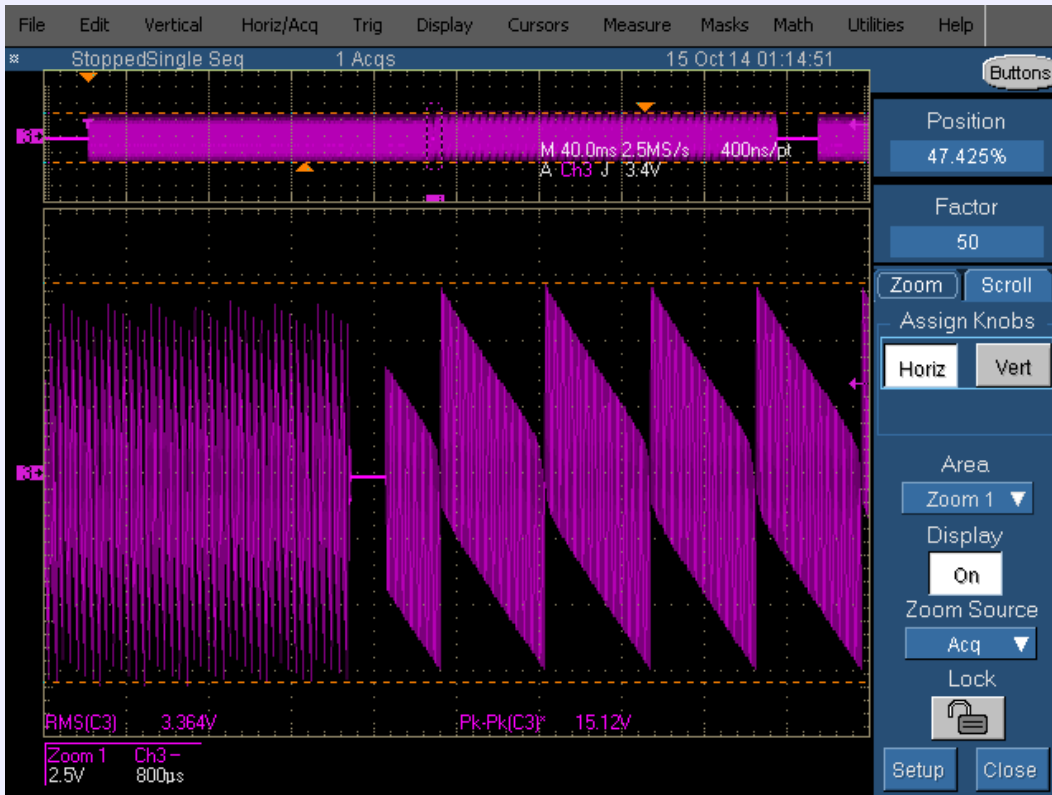
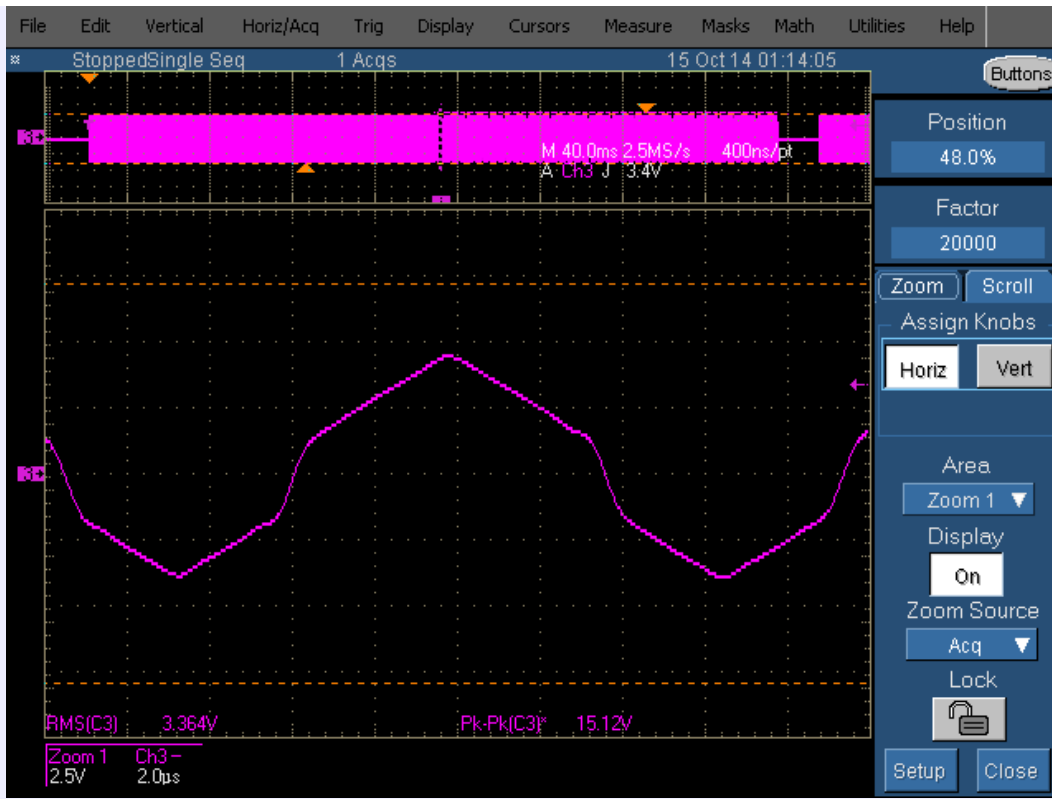
U142 EL2018 comparator output to digital domain of ADC:

It does seem to be working, at least signal is there. This could also indicate that problem lies in timing/sync, which is more difficult to troubleshoot, as we don't know correct waveform timings.

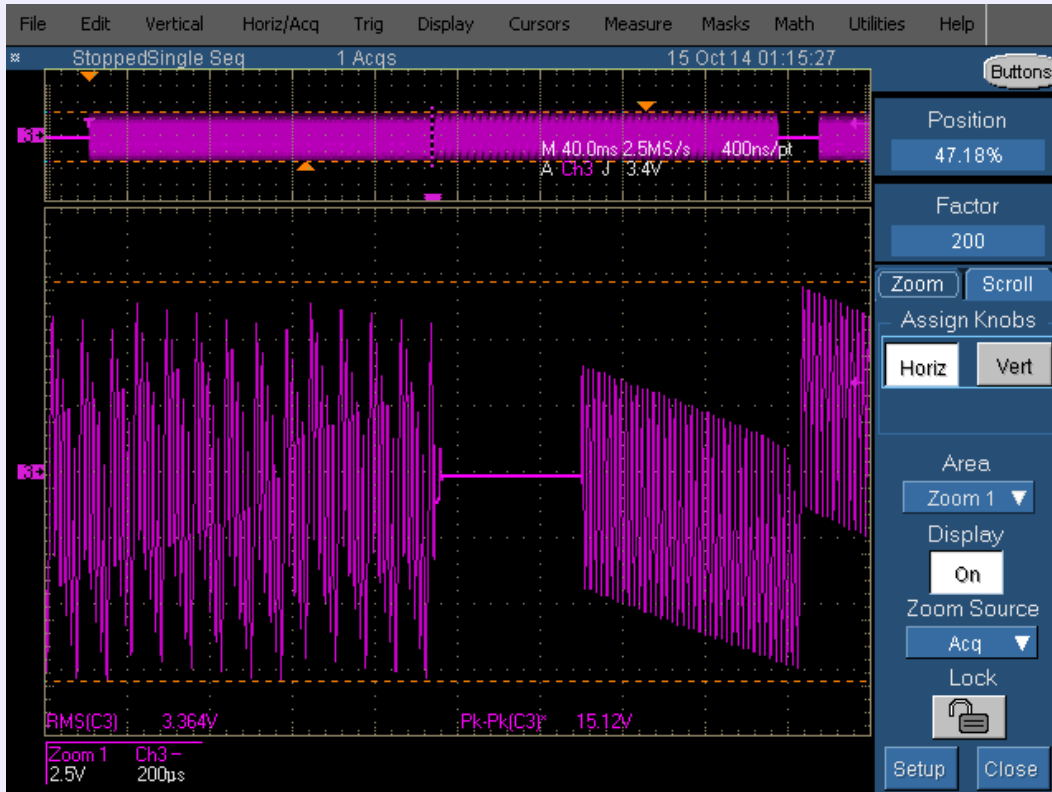
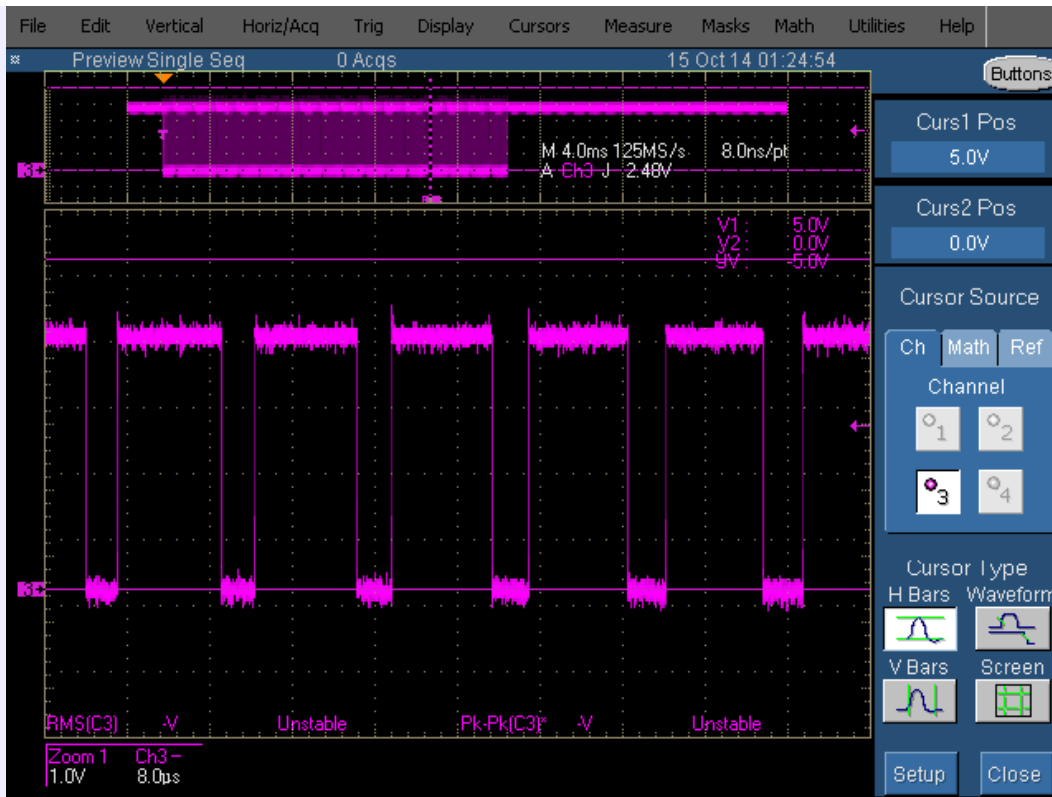
Above two blocks of pulses, first fast ramps and then slower ramps. Longer pulse train usually have valid measurement displayed on screen.

Sometimes there are only first half of pulses, and also aborted conversion without value shown on screen. Square pulse train waveform is comparator's output.

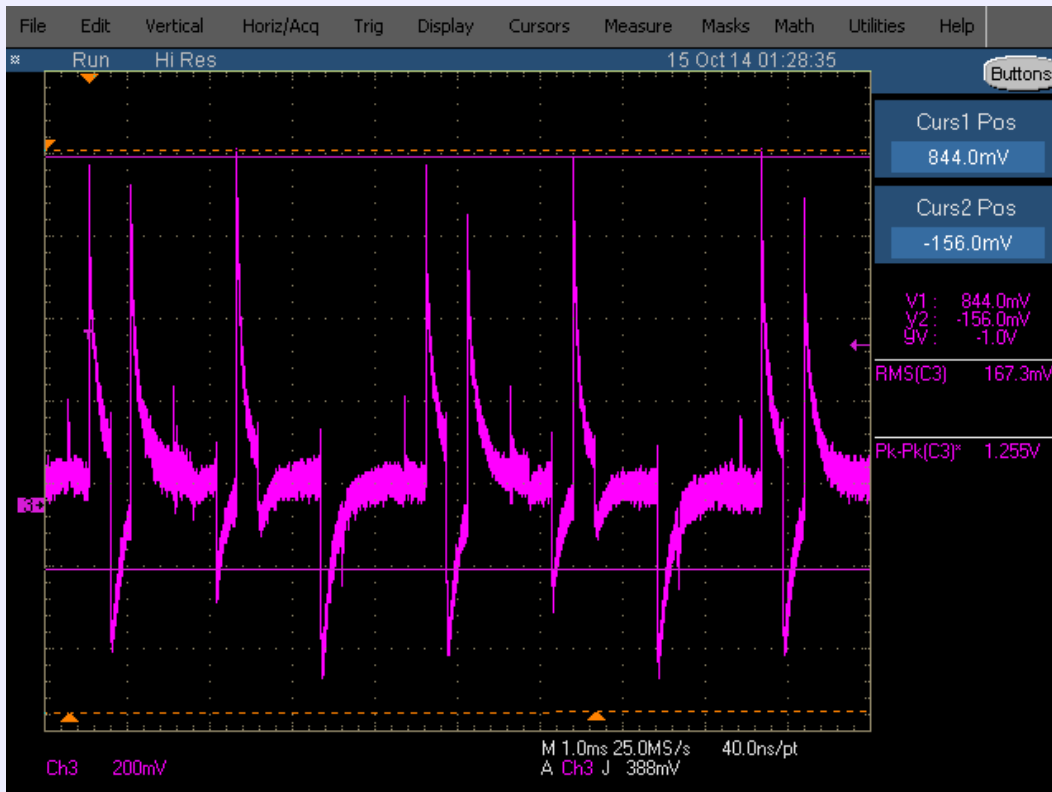
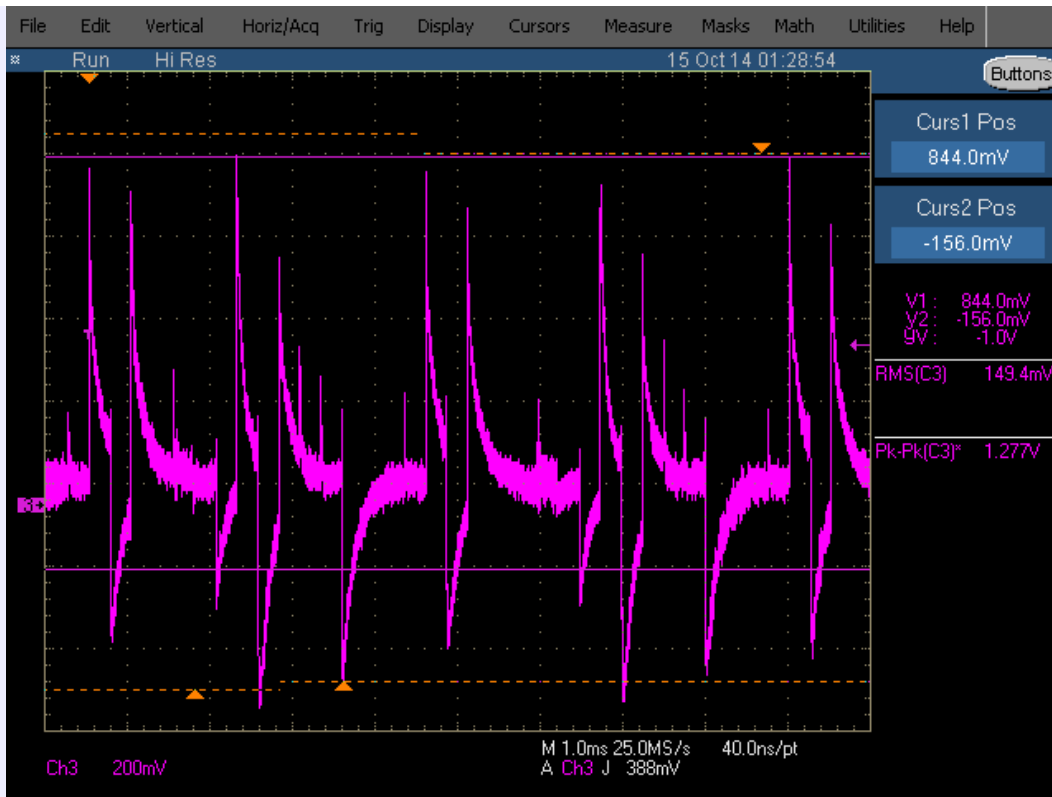
A2 Board, U504 buffer (left input pin 2, right output pin 3), meter in mV range on ACV.

Looking OK, despite U504 running rather warm.

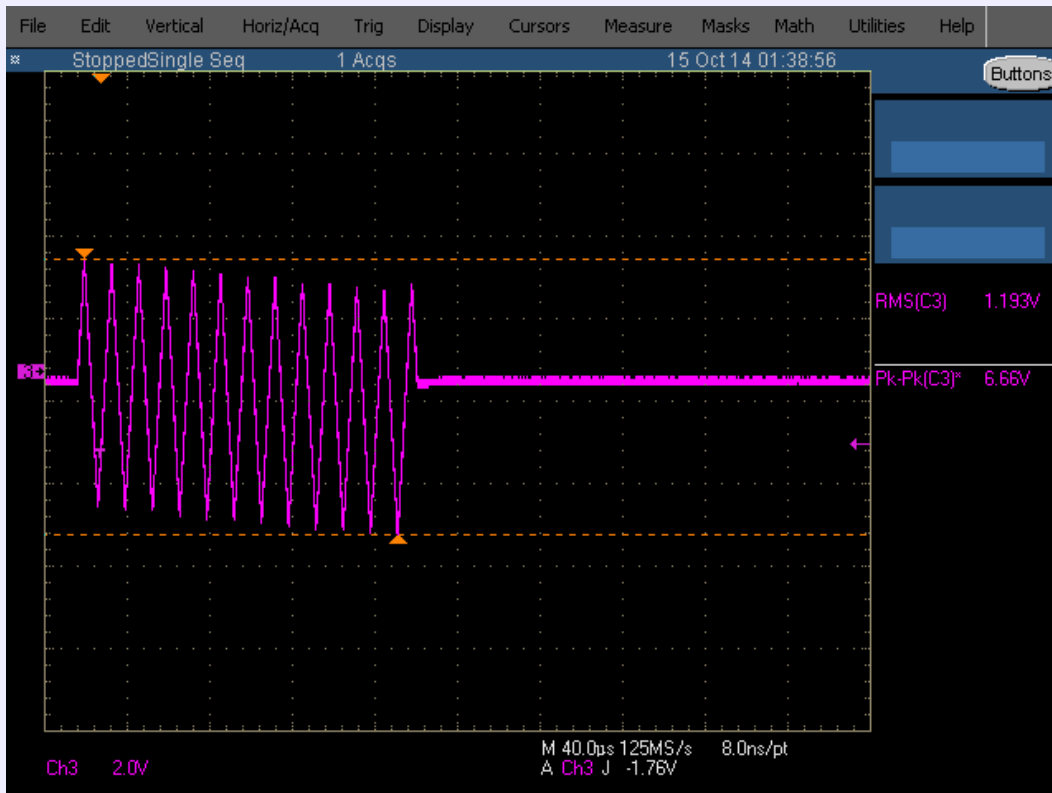
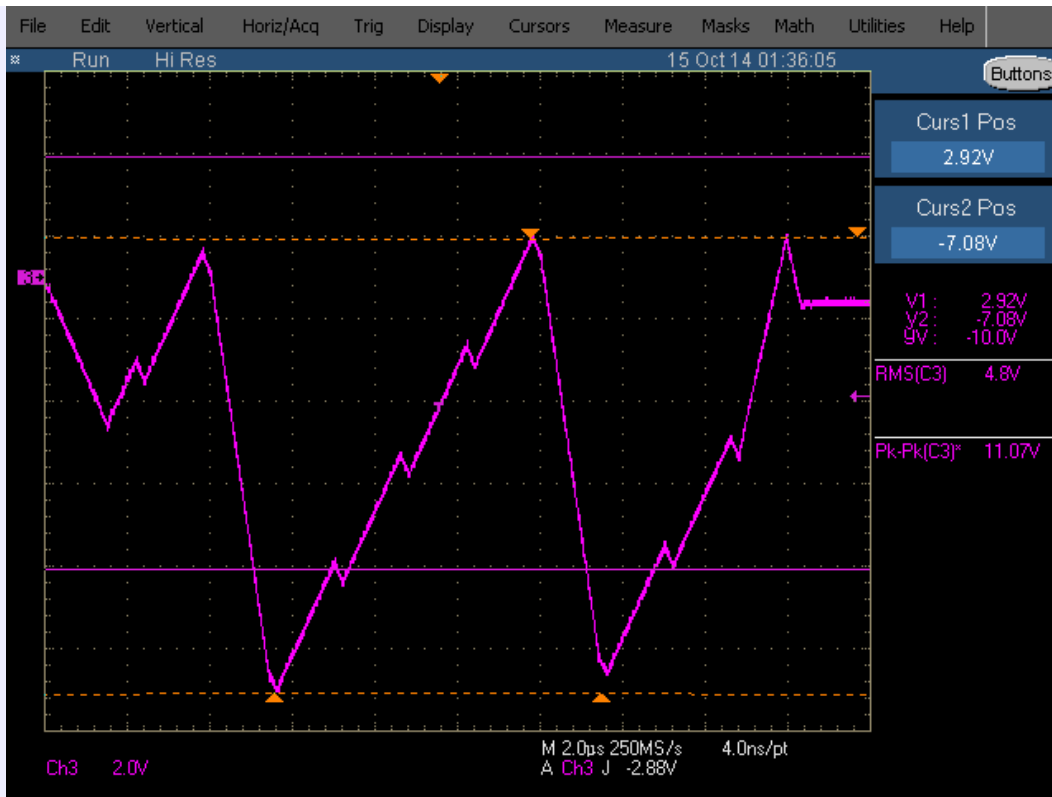
Integrator capacitor waveform (test point TP112, left is NPLC 0.001 failing, right is NPLC 0.0001). Can easily see on faster setting it just takes 2 big ramps to converge voltage, while on slower setting it takes 12 much smaller ramps.

Not sure if those little dips should be there...

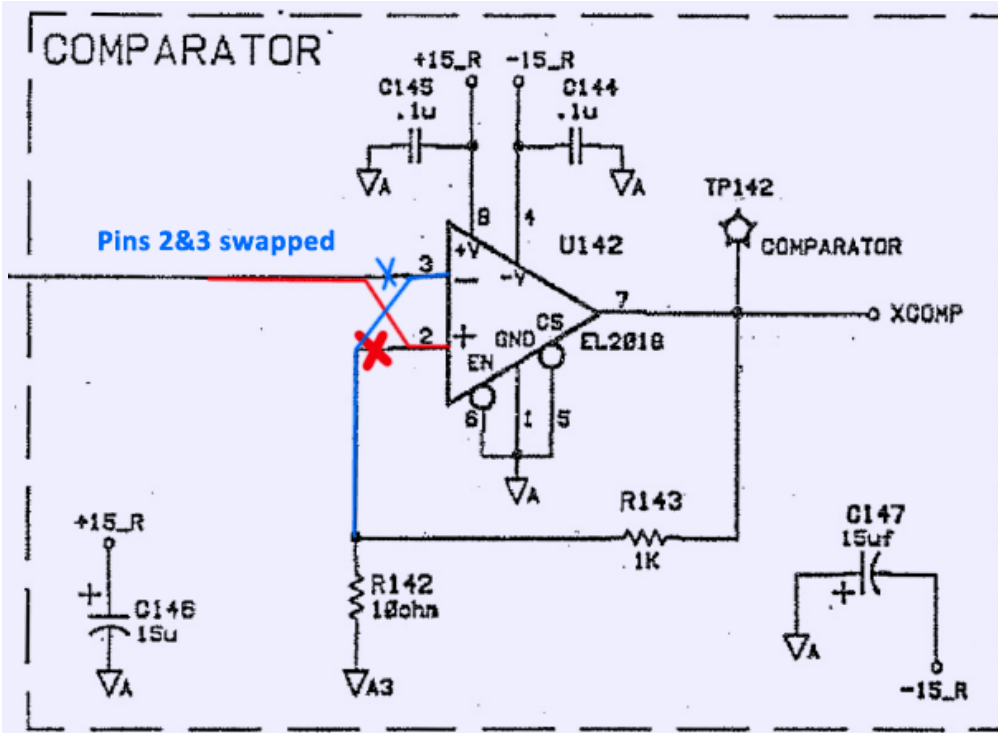
Also there is an error in HP 3458A CLIP, regarding U142 comparator inputs. They are swapped on schematics, so slope amplifier actually connected to non-inverting input of comparator, pin 3.

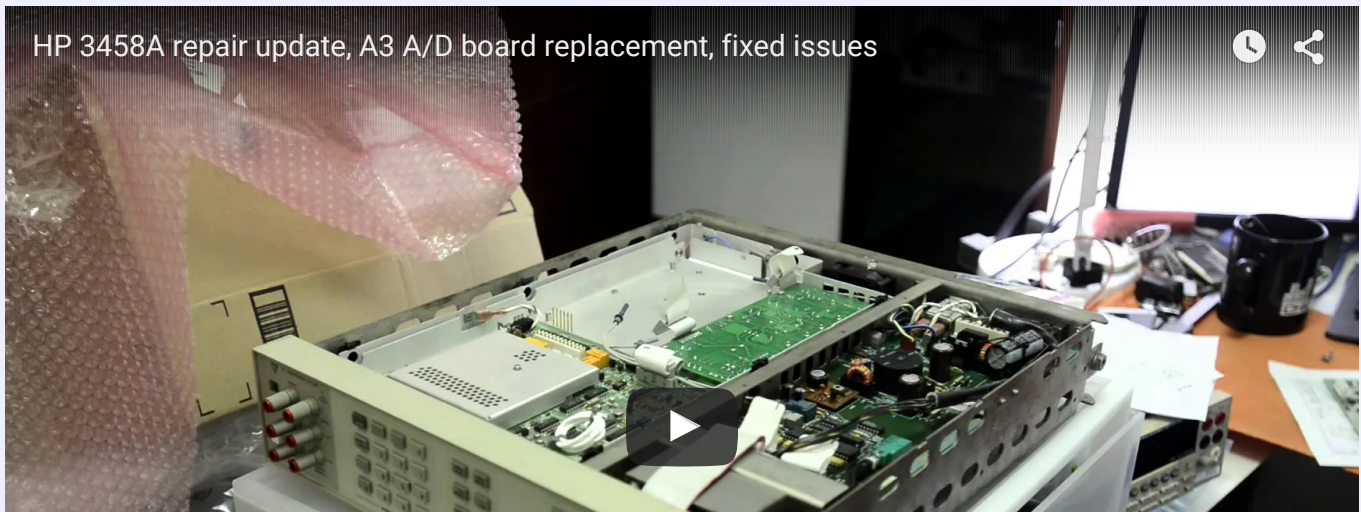
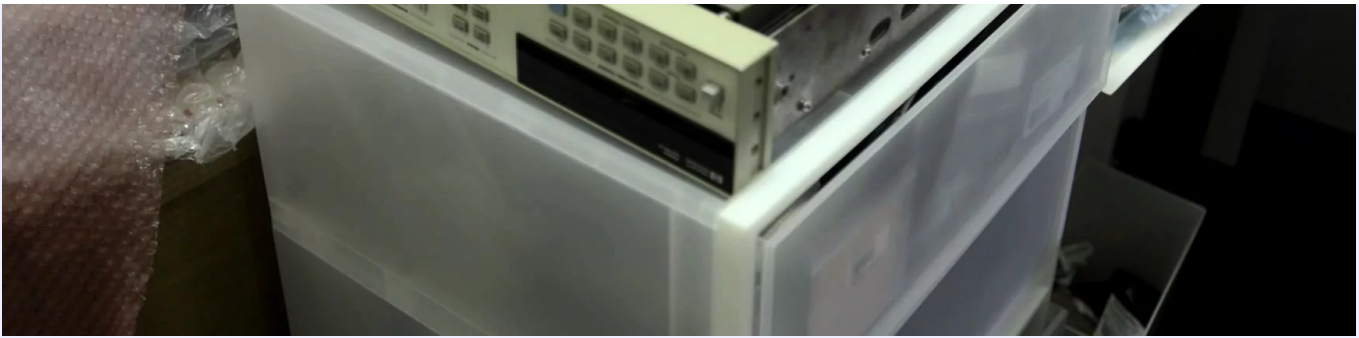
This issue is due faulty **U501** EL2018 comparator on A2 AC PCBA. After replacement with good EL2018 this issue was resolved.

Now meter running non-stop, to see if we can get any issues.
